Applications of Non-destructive Tests for Diagnosis of Heritage Buildings: Case Studies from Singapore and Malaysia

Chung Wan Wong

MAEK Consulting Pte Ltd, Singapore
Email: wongcw@maek.com.sg

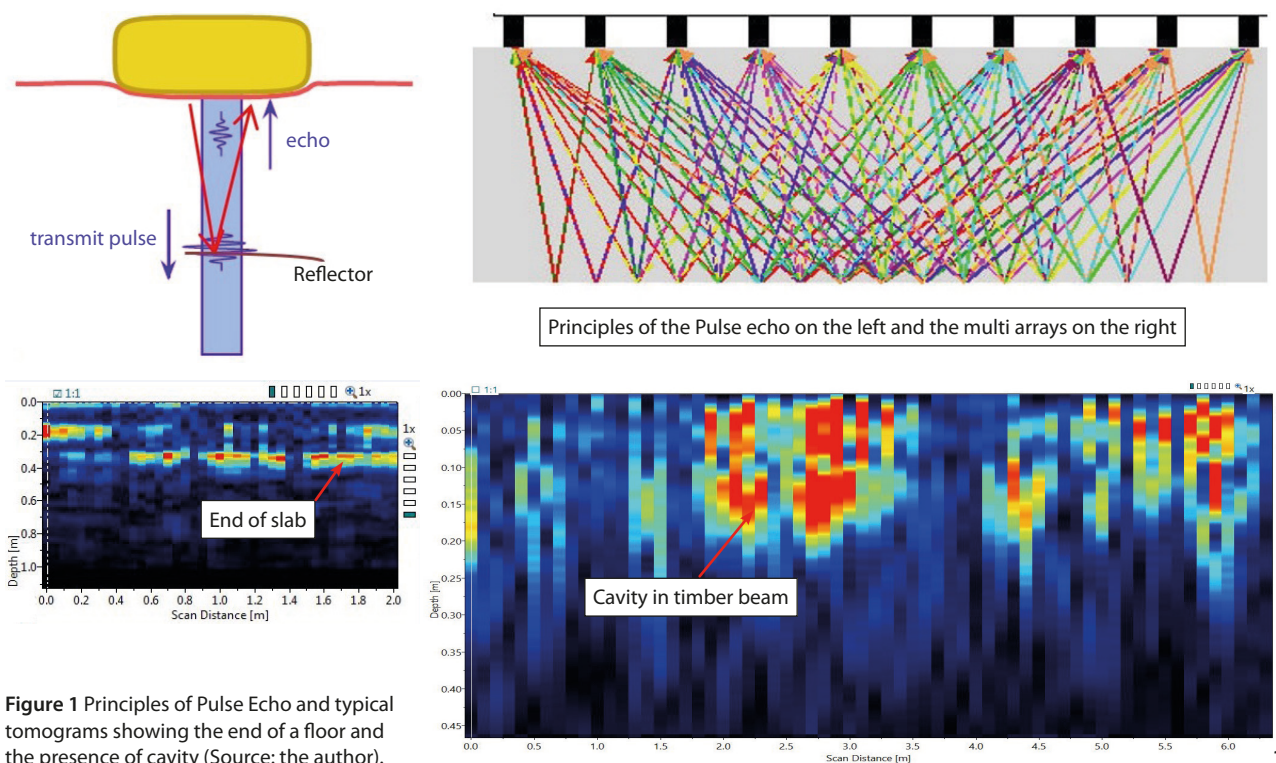
Figure 1 Principles of Pulse Echo and typical tomograms showing the end of a floor and the presence of cavity (Source: the author).

its application for masonry construction has been fraught with difficulties due to the largely heterogeneity of such construction arising from the interfaces of masonry units and mortar joints. Such interfaces had resulted in multiple echoes which had masked other features of interests such as void and embedded objects. Recent trials however on structural timber members revealed that this technique can be used to check for rot and termite attack (Figure 1).

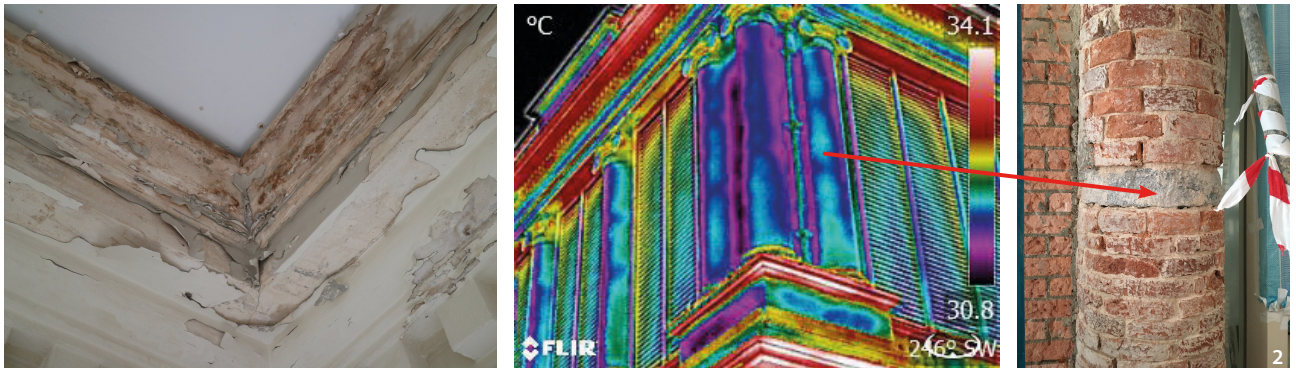
Figure 2 Left photo shows deterioration of internal decorative plaster due to water ingress from external and salt attack. The thermogram taken from the external showed the presence of thermal profiles on columns which were later found to be granite discs erected as part columns construction to even the load bearing (Source: the author).

In one of the mid-19th-century building constructed of masonry load bearing members, salt attack and water seepage have resulted in deterioration of the internal decorative cornices and ionic column capitals. From the infrared thermographic inspection on the external façade, regular thermal patterns could be seen on the circular columns, which were subsequently found to be circular granite discs installed at regular intervals along the height of the columns (Figure 2). This is because the granite discs have lower thermal heat capacity and tend to absorb heat better than the clay brick units. This thus resulted in the render around the granite

disc appearing cooler during the solar heating stage (morning) as the granite discs absorb the heat. The discs were later uncovered to have been traditionally laid to allow even bearing of the load in the columns.

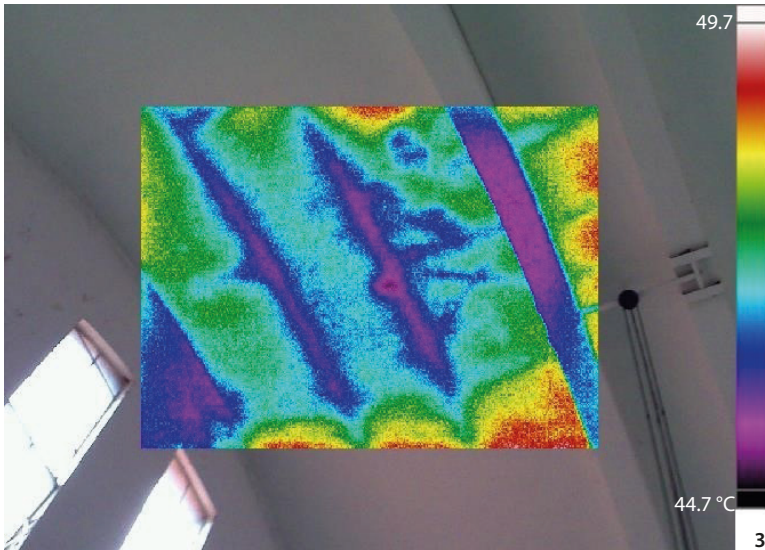
Figure 3 The thermogram on the left taken from the internal of the roof at the Tanjong Pagar Railway Station revealed the presence of roof topping (Source: the author).

At the Tanjong Pagar Railway Station which was constructed in the early 20th century, the infrared thermographic survey revealed the presence of regular thermal patterns (cold strips) on the thin shell vault roof as recorded from internally (Figure 3). Due to their regular features, these are not thought to be typical of sub-surface defects. Rather, the fact that they appeared as cold spots taken during hot days suggests the outline of roof-topping, possibly with irregular insulation properties. The areas with better insulation such as air void could have prevented heat flow through the roof thus appearing as colder spots from internally. Invariably verification via tactile inspection is necessary.

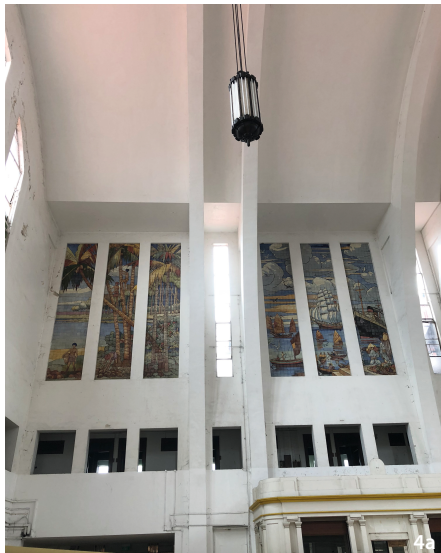
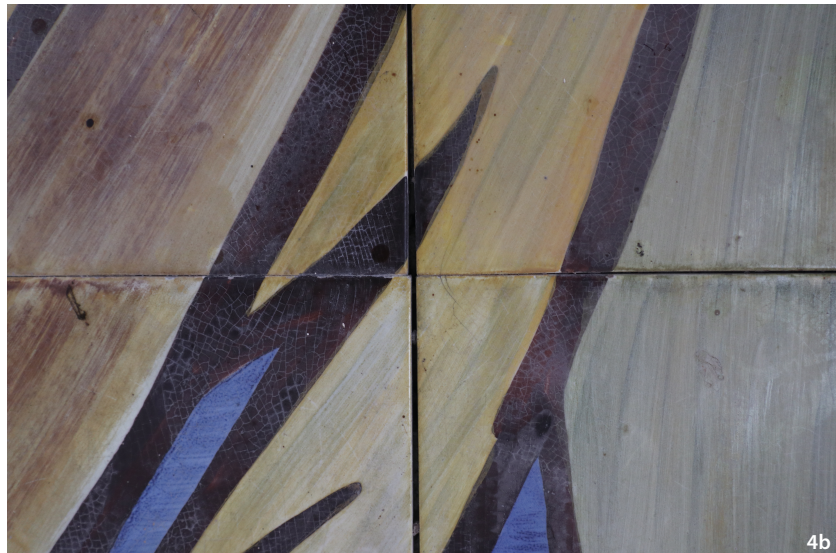
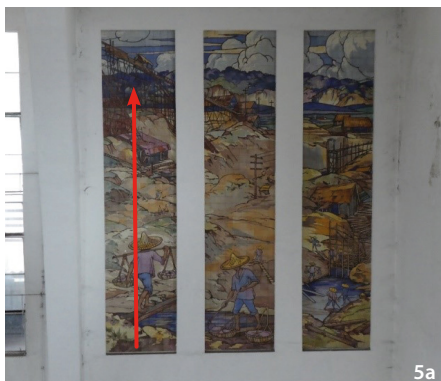
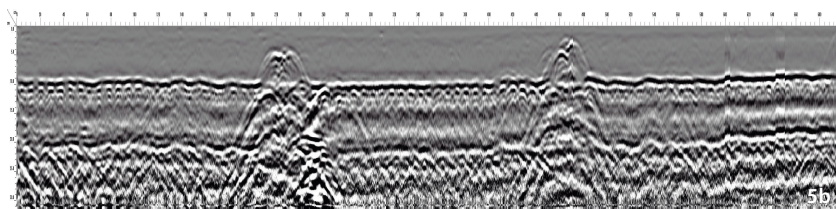
Figure 4 Left photos shows part of the mural tiles at the Tanjong Pagar Railway Station. A close up view of the hand painted tiles is shown in the right photo (Source: the author). **Figure 5** Radar scanning carried out along the mural tile (left photo) with the resulting radargram shown in the right photo. The thickness of the wall is about 400 mm and is made up of brick masonry. Two equally spaced lintel or steel reinforcement could be seen from the protruding parabolas in the radargram (Source: the author).

As the mural tiles are showing signs of cracks, crazes and debonding, there was a need to establish the construction of the walls on which the tiles were laid. In the absence of as-built drawings for the non-load bearing walls, radar was used. The scan revealed that the tiles were installed onto ~400 mm thick brick walls with intermediate beams/lintels equally spaced over the height of the walls (Figure 5), and flanked by concrete beams at the top and columns in between each panel of mural tiles. These are important findings in assessing the stability of the in-fill walls and hence the invaluable mural tiles.

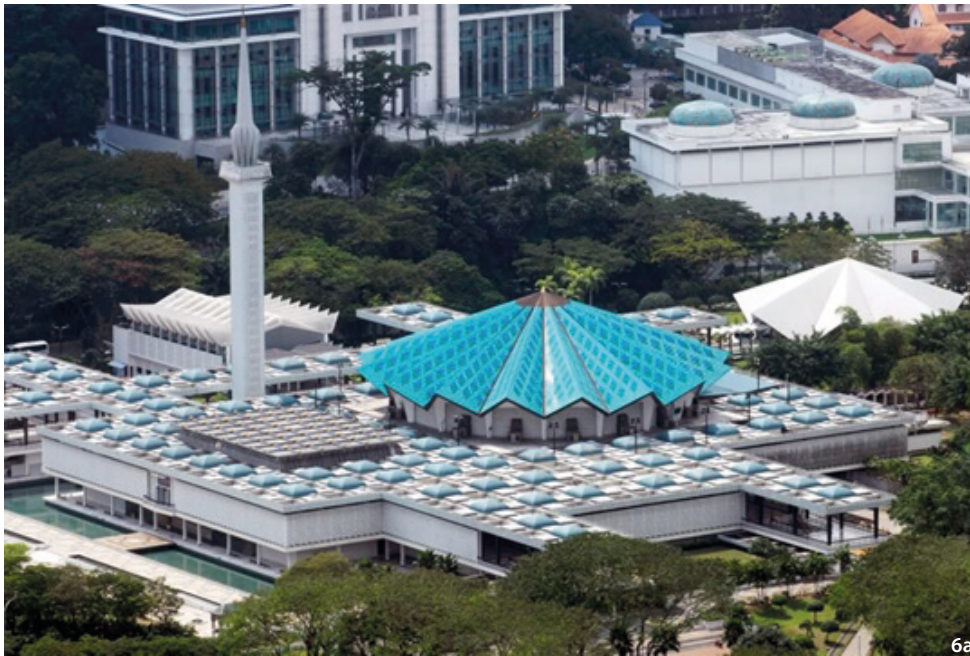
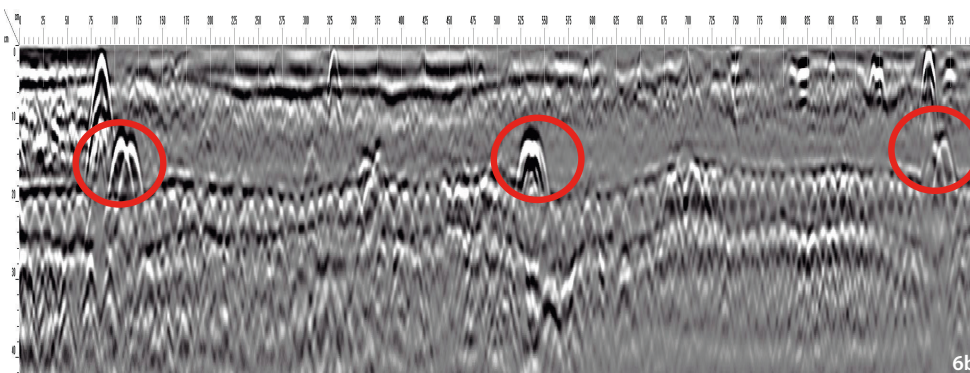
the locations of embedded services and pipes in particularly metal rainwater pipes. The pipes were apparently embedded within the concrete structures, but there is no record as to the locations and layout. Through the use of GPR scanning, the locations of the pipes were found embedded in some of the concrete columns and slabs. These are clearly evident from the presence of parabolas in the resulting radargrams (Figure 6). In fact, the parabolas appeared in pairs suggesting that there are two pipes at each location. The pipes appeared approximately in the mid-thickness of the slab as the bottom layer of steel reinforcement bars could be easily discerned. The marble tiling layers cause the presence of multiple echoes at the top of the slab.

Figure 6 The radargram below revealed the locations of embedded rainwater pipes within the floor slab at the National Mosque in Kuala Lumpur, Malaysia (Source: the author).

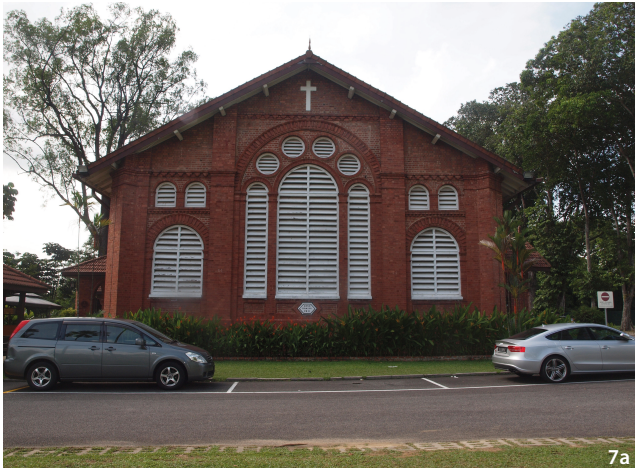
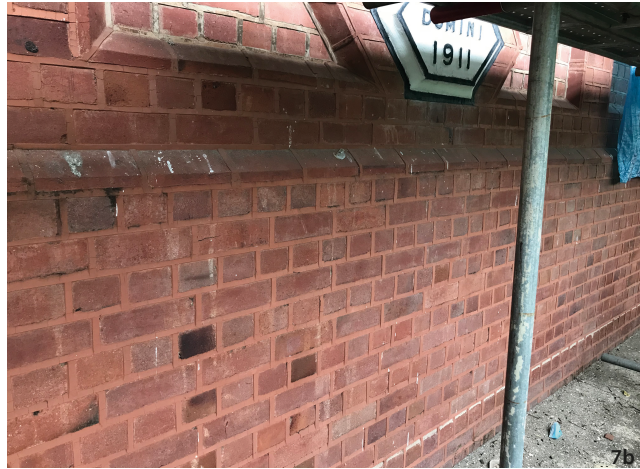
Figure 7 Fair faced brick façade of St. George's Church. A damp proof course could be seen near the foot of the wall as noted on the external façade in the right photo (Source: the author).

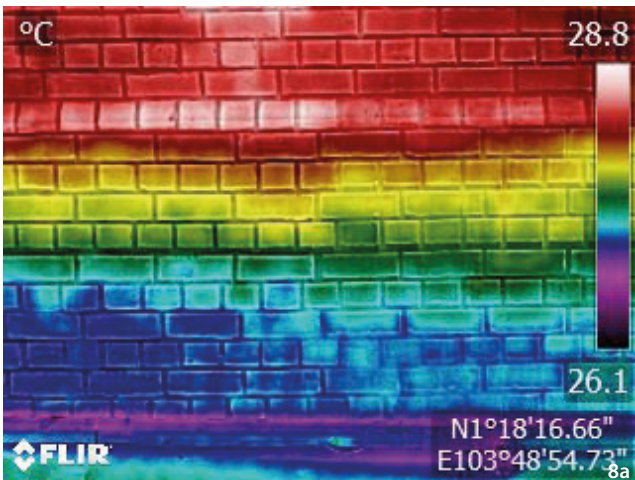
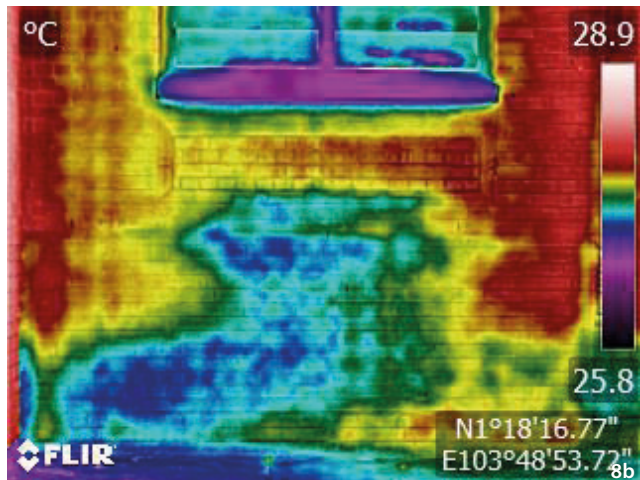
to below a damp proofing layer indicating the effectiveness of the damp proof course. This appeared largely as cold spot when the survey was carried out in the morning. This is due to the high thermal heat capacity and evaporative cooling of moisture rendering the damp area as cooler spots. At localised areas, however, dampness could be detected above the damp proof layer indicating isolated breach of the layer (Figure 8). From here, targeted rising damp treatment was being carried out. Internally, localised moisture was also found on the roof and some of the timber rafter, again appearing as 'cold spots' (Figure 9). This would then allowed detailed further investigation of the condition of the timber for wet rot, which would otherwise have gone undetected.

Figure 8 Dampness due to rising damp below the damp proofing layer is shown at the St George's Church as seen in the centre thermogram. The right thermogram indicates dampness above the damp proofing layer (Source: the author).

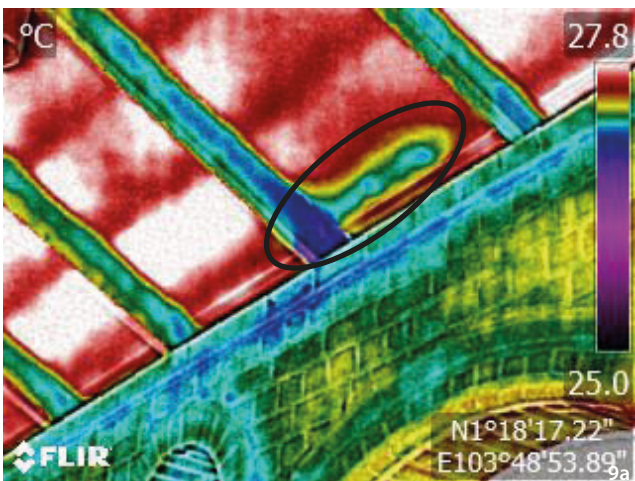
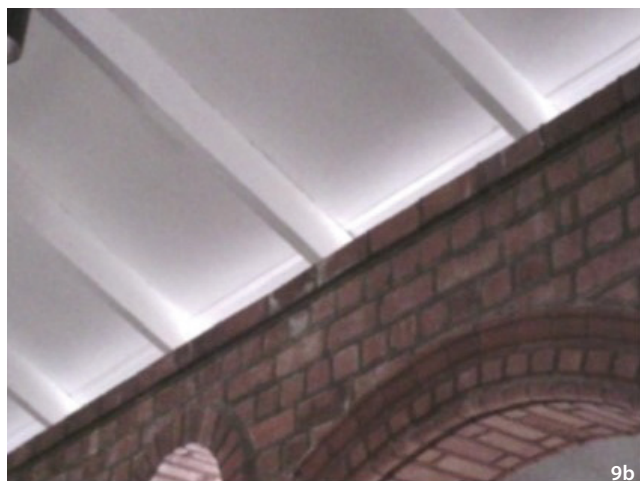
Figure 9 Trapped moisture in a timber rafter which could be potential for wet rot and seepage through the roof was detected through the presence of cold spots from the thermogram at St. George's Church (Source: the author).

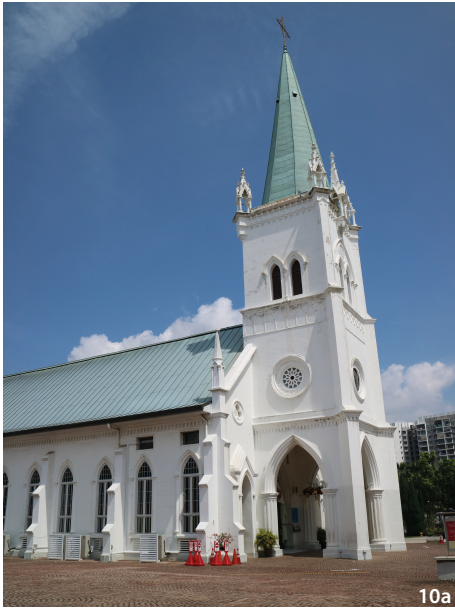
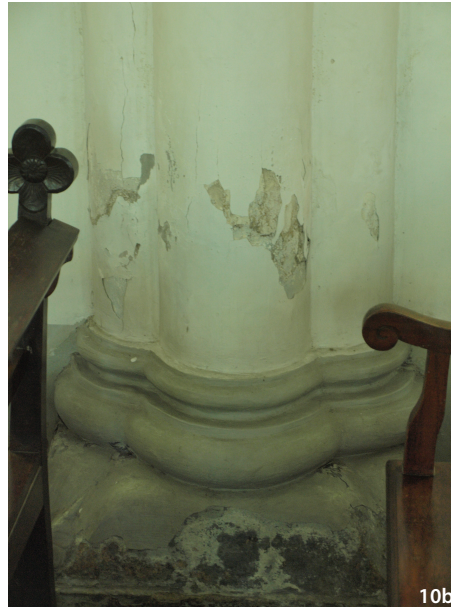
of deteriorated and friable plaster accompanied by salt crystals could be seen (Figure 10). Even the use of infra-red thermography was not able to identify the presence of rising damp due to the thick layers of paint that had

Figure 10 The left photo shows the Church of the Nativity of Blessed Virgin Mary. In the right photo, localised deterioration of the internal plaster around columns could be noted (Source: the author).

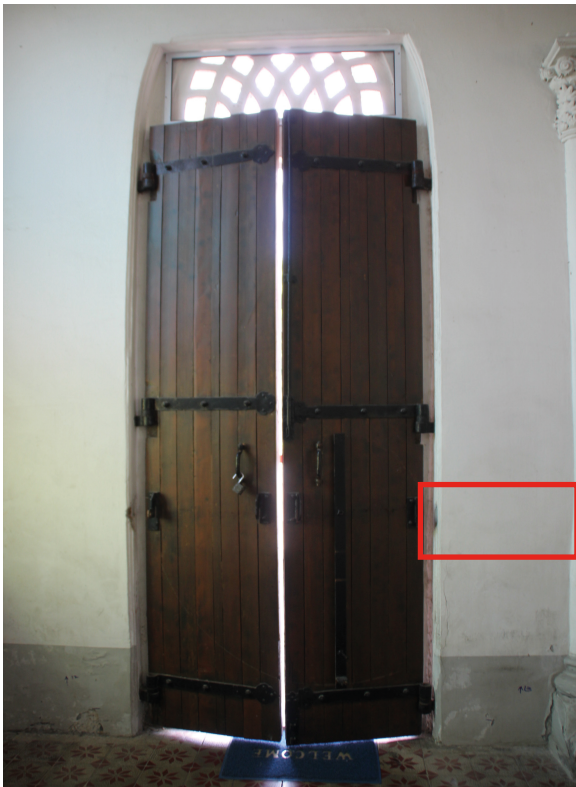
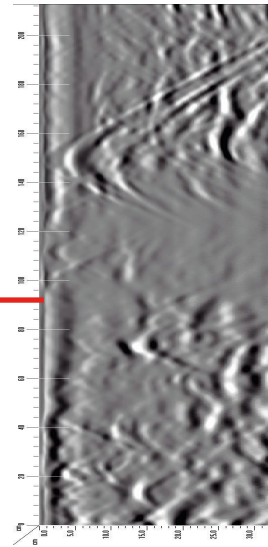
Figure 11 The radargram above exposed the zone with trapped salt within the wall at the Nativity of Virgin Blessed Mary identified from the attenuated electromagnetic signal despite the absence of visual symptom (Source: the author).

symptom. These appeared as severely attenuated electromagnetic signals due to the high dielectric constant of the soluble salt (Figure 11). These were subsequently verified with dust sampling and salt content analysis via ion chromatography. The salt was later identified to be made up predominantly of chloride.

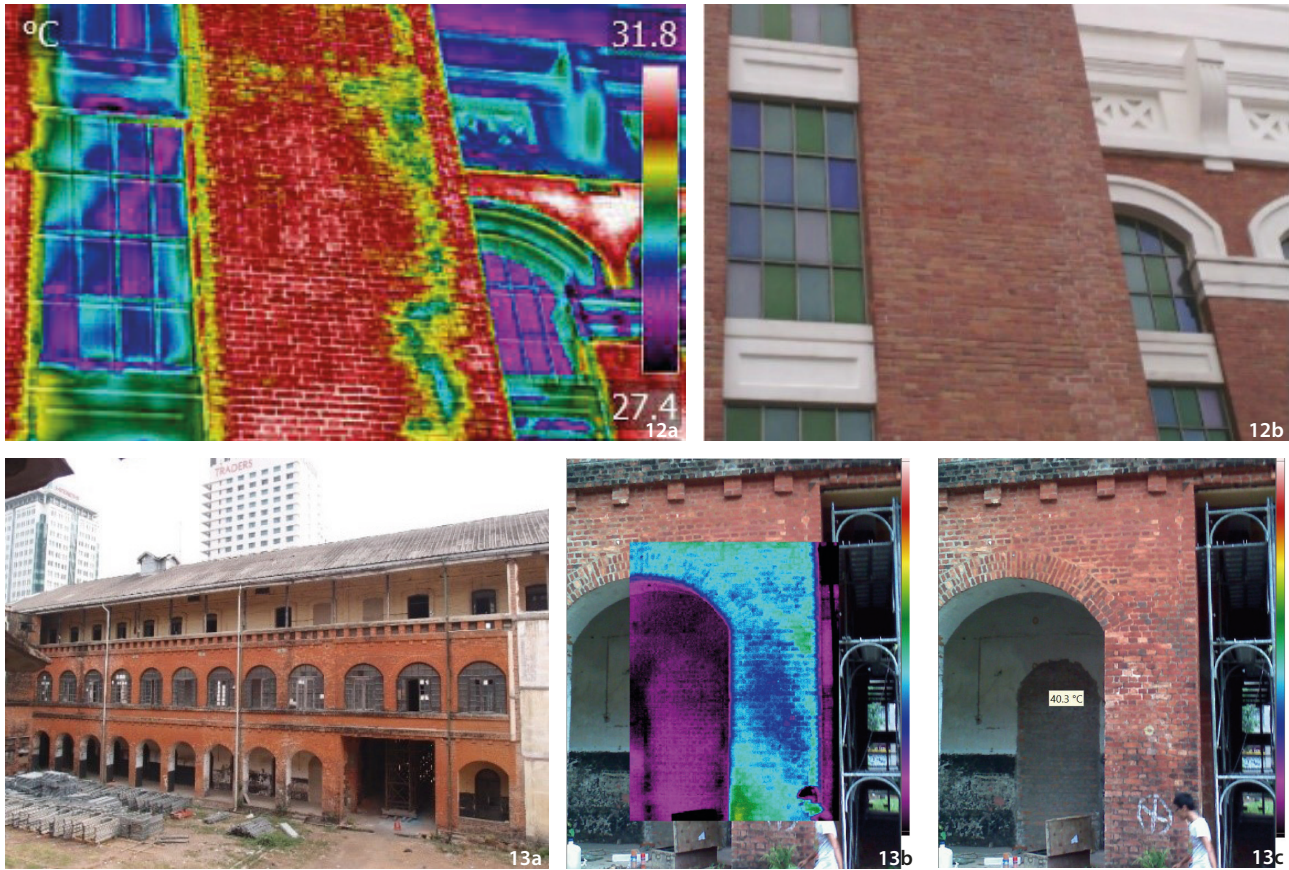
Figure 12 The presence of cracks could be highlighted from the infrared thermography at the St. James Power Station, taken after a short bout of rain. The ingress of water resulted in the crack line showing lower surface temperature (Source: the author).

Identification of defects is one of the most common applications in most NDTs. The use of infrared thermography had helped to identify the presence and extent of cracks in the fair-faced brick façade at the St. James Power Station by inspecting a wet spell (Figure 12). These appeared as cold spots due to the higher thermal heat capacity of

water which takes a longer time to heat up when exposed to solar radiation and its evaporative cooling effect. This again demonstrated that passive thermography can be employed by making full use of the weather and timing in façade inspection. Close up inspection will then be needed to ascertain the extent and cause of the cracks.

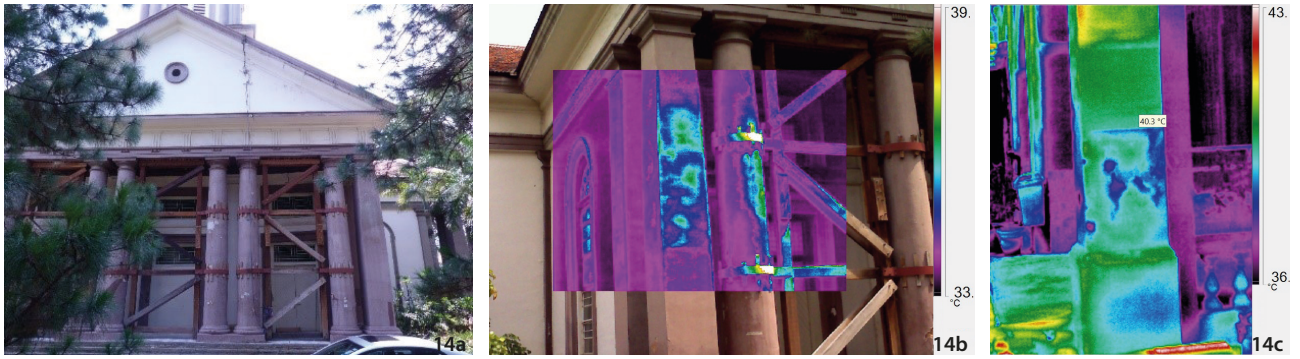
The infrared thermography had also picked up deteriorated brickworks at the Myanmar Railway Station Building in Yangon and defective render works at the Cathedral of Good Shepherd in Singapore (Tang, Krishnankutty and Wong 2013). At the former, deteriorated bricks will have different thermal heat capacity due to its porosity or water retention often giving rise of lower temperature profile as compared to sound bricks (Figure 13). At the Cathedral of Good Shepherd, from the thermograms captured on the façade after prolonged heating by solar radiation, the presence of ‘cold spots’ was linked to deteriorated render, but hot anomalies were subsequently found from breakout to be due later applied cement based render (Figure 14). This thus helped to identify locations of inappropriate cement render that had been applied onto historic brickworks

Figure 14 The left photo shows a section of the Cathedral of Good Shepherd. The centre and right photo show thermograms captured with thermal anomalies. The irregular cold spots are an indication of deteriorated and debonded render. A regular hotter area above the irregular cold spots in the right photo is due to the presence of latter applied cement-based render. This was applied apparently to address the deterioration of the historic render caused by the salt attack (Source: the author).

which need to be removed as they are detrimental to the historical layers. The cement rich renders are too strong for the historical layers which can cause damages to the weaker render and substrate. In addition, such render can also be an additional source of soluble salt which can aggravate the deterioration of the traditional substrate.

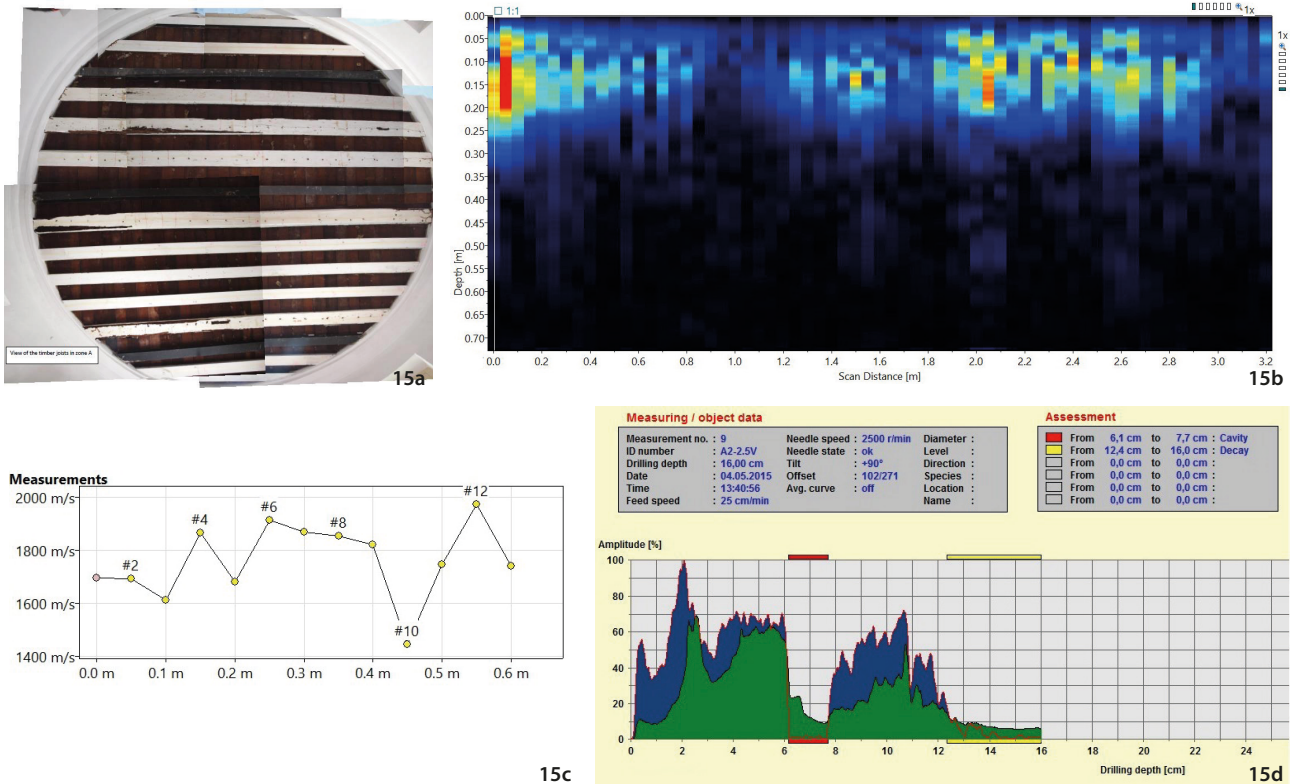
Figure 15 Top left photo shows the layout of the timber floor joists at the Caldwell House. The image at the top right shows a typical tomography of the pulse echo from a joist with cavity. The cavities appeared as reflected echoes. In the bottom left graph, variations in the ultrasonic pulse velocity are revealed with the localised cavity showing a much lower velocity. The size of the cavity was finally estimated with the timber resistograph is demonstrated in the bottom right graph (Source: the author).

During the restoration of the former Convent of Holy Infant Jesus Middle Education School (CHIJMES), extensive subterranean termite attack was uncovered on the timber floor joists at the Caldwell House, which was built

spots with cavities (Figure 15). This then allowed the true condition of the joists to be determined and appropriate repair methods designed for.

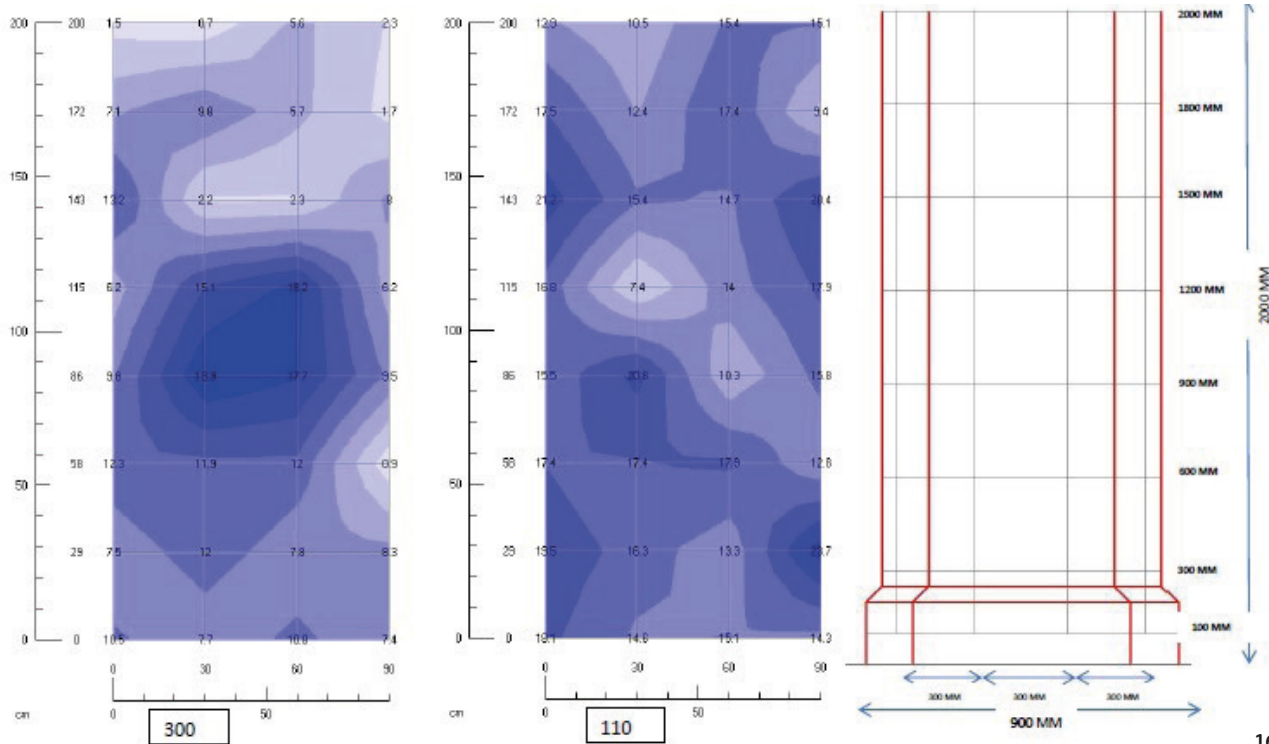
Figure 16 Microwave moisture tomograph on one of the columns showing moisture distribution at different depths. At about 300 mm depth, a concentrated zone of much higher relative moisture content was detected. The pattern of moisture distribution did not suggest any presence of uprising damp (Source: the author).

In the same project, rising damp and salt attack on the masonry columns were discerned and the rising damp treated via chemical injection. As with most interventions, post-treatment checks were carried out by gravimetric measurement of extracted powders. Powders of the bricks were extracted from different heights. However, in few of the columns, the brick powders showed persistently high moisture despite repeated chemical injections. This has resulted in multiple holes due to the repeated brick powders extracted, which was destructive and undesirable. The use of infrared thermography failed to identify the locations and cause of persistent dampness. Microwave moisture tomography was subsequently employed to better understand the cause and pattern of moisture distribution within these columns. The measurements were made with two different depth probes; namely 110 and 300 mm as the columns were about 500 mm thick. From the resulting tomograph, it was found that the rising treatment was effective. Instead, the high moisture was discovered to be concentrated in a localized zone about 1 m above the floor level and around the centre of the columns (Figure 16). Follow up targeted extraction of powder at this localised

spot showed a high amount of hygroscopic salt and hygroscopic moisture content. Targeted salt treatment to the specific area was then carried out which eventually resolved the problem.
