Modernised Traditional Lime Plasters for Modern Historic Living of Built Heritage: Case Studies from Germany and Reflection for China

Tanja Dettmering

Modern Use of Lime Plaster: Case Studies from Germany

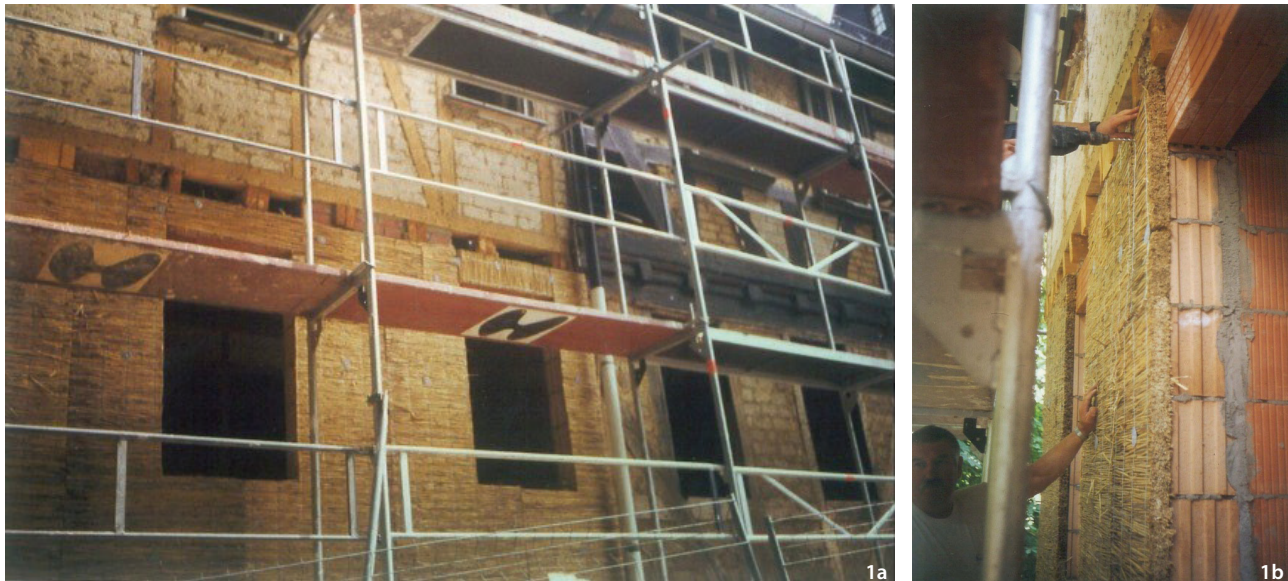
Figure 1 Reed insulation was installed during the restoration of the 'Lottehaus' in Wetzlar, Germany (Source: the author).

The thickness of the reed insulation panels was in the range of 2–5 cm (Figure 1). Insulation lime mortar, with a grain size of 4 mm, was applied over large areas of the reed insulation panels. Subsequently, a top coat of lime mortar, with a grain size of 2 mm, was applied. When the Lottehaus was originally constructed, the half-timbering on the upper floor was visible, but that became plastered over in 1750.

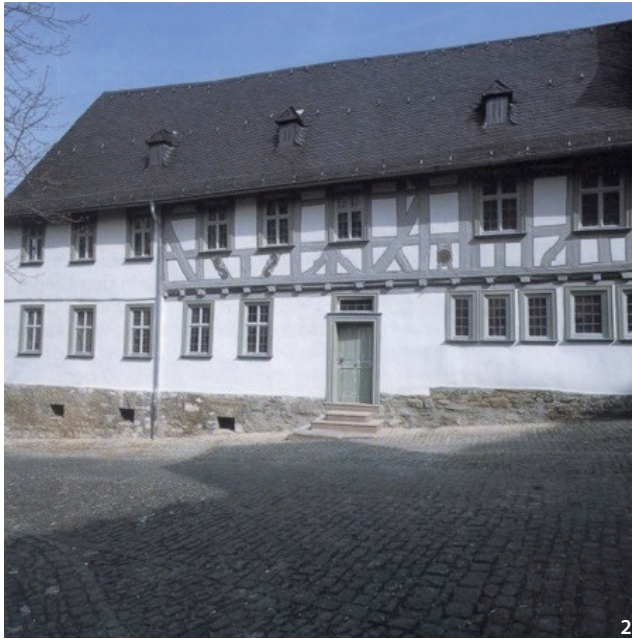
Figure 2 20 years after restoration, the Lottehaus in Wetzlar received the Hessian Monument Protection Award (Source: the author).

To reflect how the interior originally appeared, parts of an old mural were integrated into the new plaster on the ground floor. In the so-called State Room on the upper floor of the Lottehaus, decorative paintings feature antique vases and statues of Greek gods in accordance with the popularity of Greek elements with the Rococo style. As a result of the extensive interior and exterior restoration work over 20 years ago, the Lottehaus received the Hessian Monument Protection Award (Dettmering and Kollmann 2011) (Figure 2).

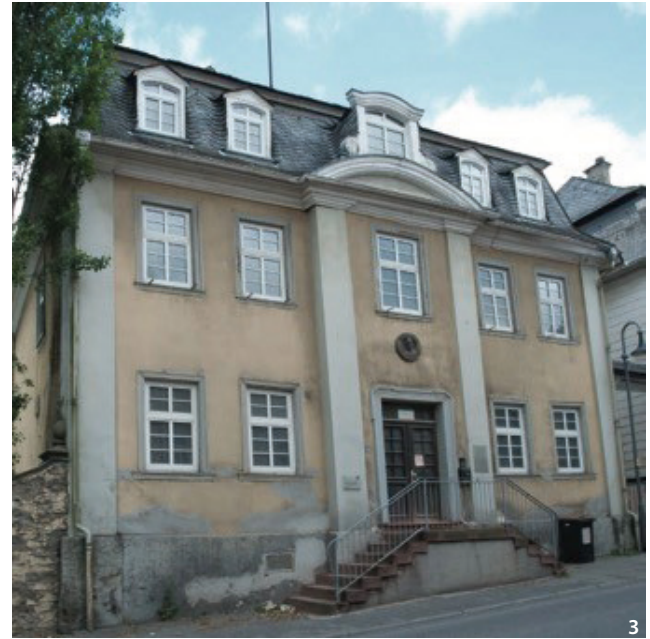
Figure 3 Usingen fürstliches Beamtenhaus before restoration (Source: the author).

The Usingen fürstliches Beamtenhaus (Princely Civil Servant House) was built in 1733–1734. The structure is of great architectural significance and is located in the residential city of Usingen, which is in the rural upland Taunus region near Frankfurt (Figure 3) (Trommer 2016). The building is very close to the Hessenpark Open Air Museum.

According to Germany's cultural heritage classification for buildings as works of art and for urban planning reasons, the fürstliches Beamtenhaus is listed as an architectural monument. The building features half-timbered stud walls and a quarry stone base. In the 1950s, it had plastering on a metal reinforcement: cement upon metal wire upon plaster (Figure 4). A purely mineral lime insulation plaster outside and within was applied to allow energy-efficient use of the structure as a residential house.

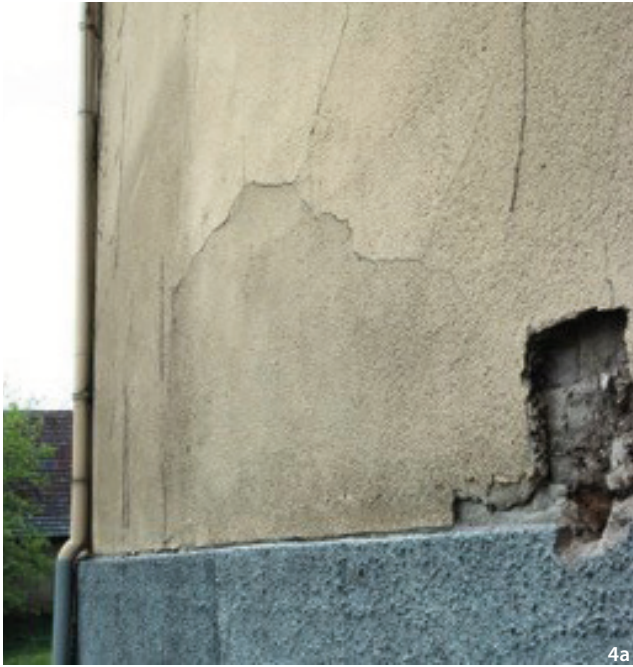
Figure 4 Cement plaster applied in the 1950's. (Source: the author).

It was decided that the plaster in the façades required basic restoration. That work involved completely removing the plaster surface that had been applied in the 1950s (Figure 4).

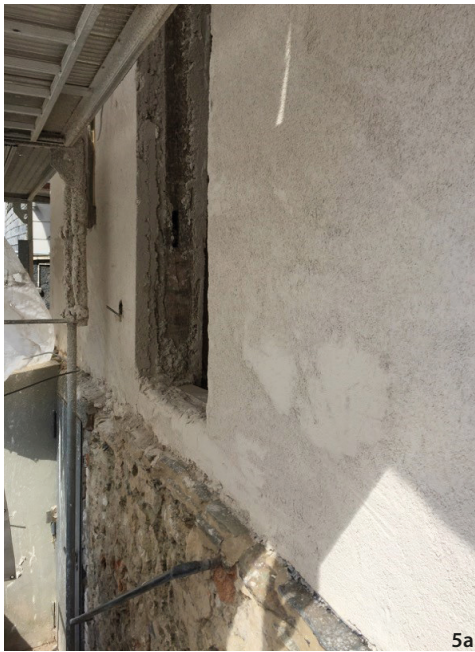
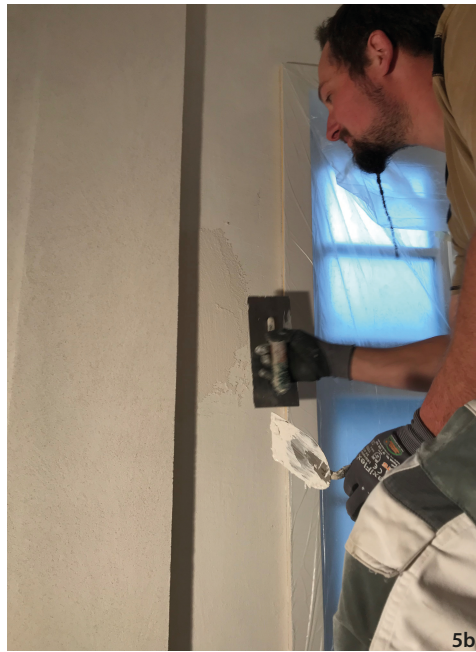
Figure 5 Ongoing restoration work with modernised lime insulation plaster in 2018 accompanied by inspections and planned to be monitored by experts (Source: the author).

For the restoration work, it was decided that using a plaster with natural hydraulic lime mortar as a binder and mineral lightweight aggregate would offer optimal thermal insulation and be in accordance with the needs of

modern living (Figure 5). The lime plaster applied to the building for thermal insulation was a factory mix with low compressive strength: the compressive strength after 28 days was 0.4–2.5 MPa.

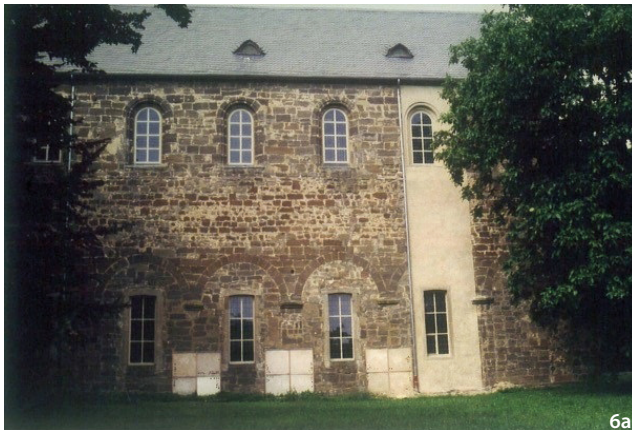
Figure 6a Heavily weathered tufa with mortar residues (Source: the author).

At Spieskappel, loss of the exterior plaster left the natural stone masonry without protection from the weather; accordingly, the masonry began showing considerable damage (Figure 6). That resulted in high susceptibility to changes in moisture, which led to swelling and shrinkage within the masonry. The result was structural disorders, cracks, and expansion zones in the masonry and detachment of up to 10 cm. Thus, it was decided that preservation and restoration of the tuff masonry would have to be undertaken. In particular, the concept of a 'sacrificial plaster', which would serve as a protective layer for the stone, was adopted.

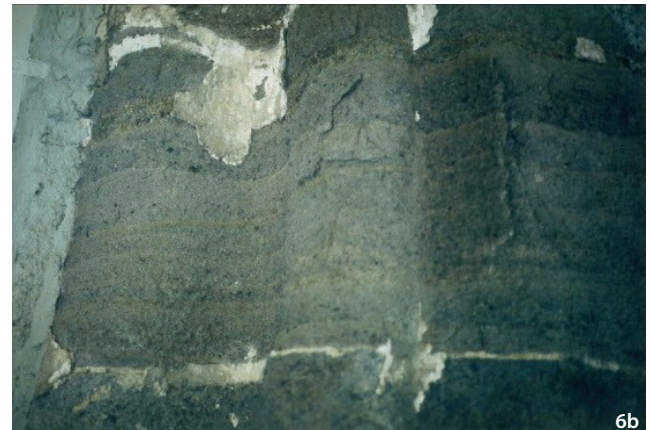
Figure 6b Macroscopic image of a tufa stone (predominantly basalt, embedded in a clayey, smectitic matrix (Source: the author).

When developing the plaster for the restoration work at Spieskappel, the characteristics of the stone used for the masonry—notably the very low compressive strengths (about 8.8 N/mm^2 on average) and moduli of elasticity (7.2 N/mm^2)—had to be considered. For low frost resistance, the high porosity and water absorption coefficients ($9.8 \text{ kg/m}^2 \cdot \text{h}^{1/2}$ on average) also had to be taken into account.

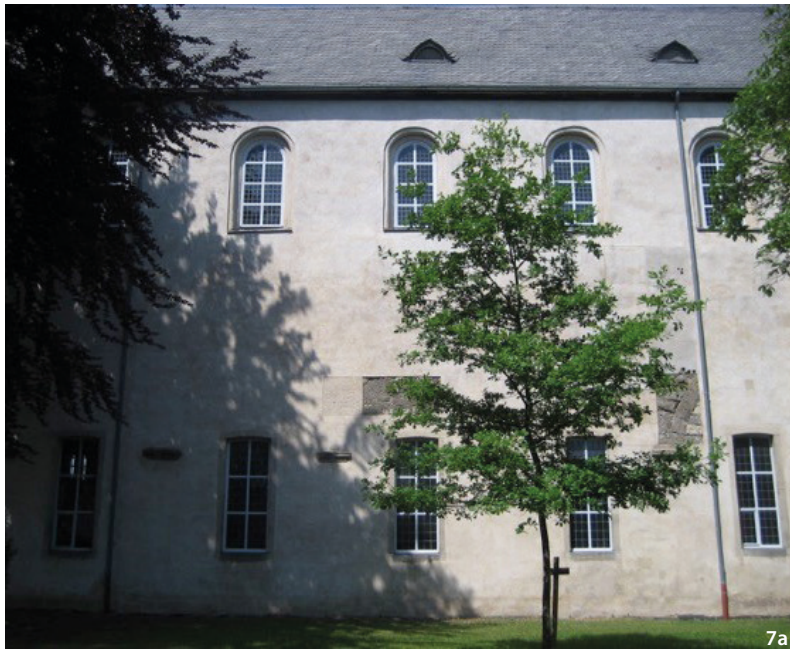
Figure 7a South façade, one decade after the application of the sacrificial lime mortar based on natural hydraulic lime (Source: the author).

Today, 20 years after the restoration work at Spieskap-pel, the specially developed natural plaster still effectively works as a protective layer for the delicate tuff. In 2017, the sacrificial plaster itself received a protective coat of a lime-based paint.

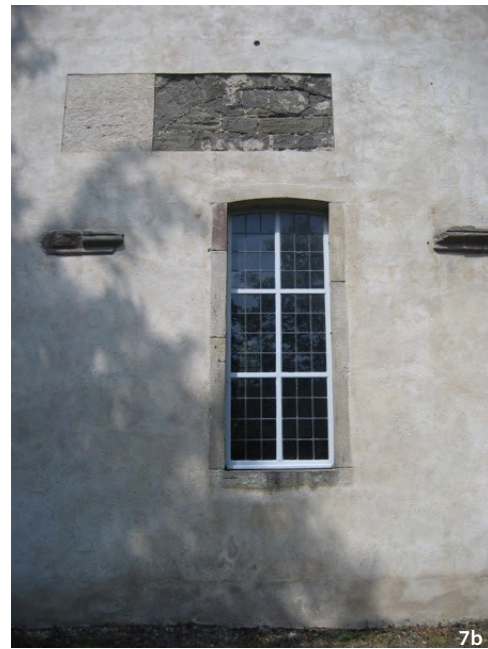
Figure 7b The 'window to history' (Source: the author).

Following five years of investigation at Spieskappel, experts decided that the best course would be to conduct restoration using a natural plaster made of natural hydraulic lime and locally available coloured sand. The restorative plastering took place in 1998–1999. The previous appearance of the church with its stone facing was intentionally changed (Figure 6, Figure 7). Above the arched lower-middle windows on the southern facade, a ‘window to history’ was created, which offered a view of the original, underlying tuff and plaster. That window also offered a possibility of monitoring the condition of underlying stone.

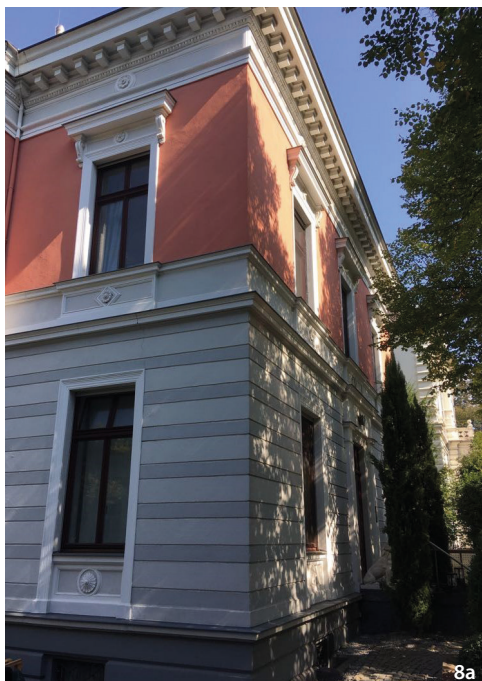
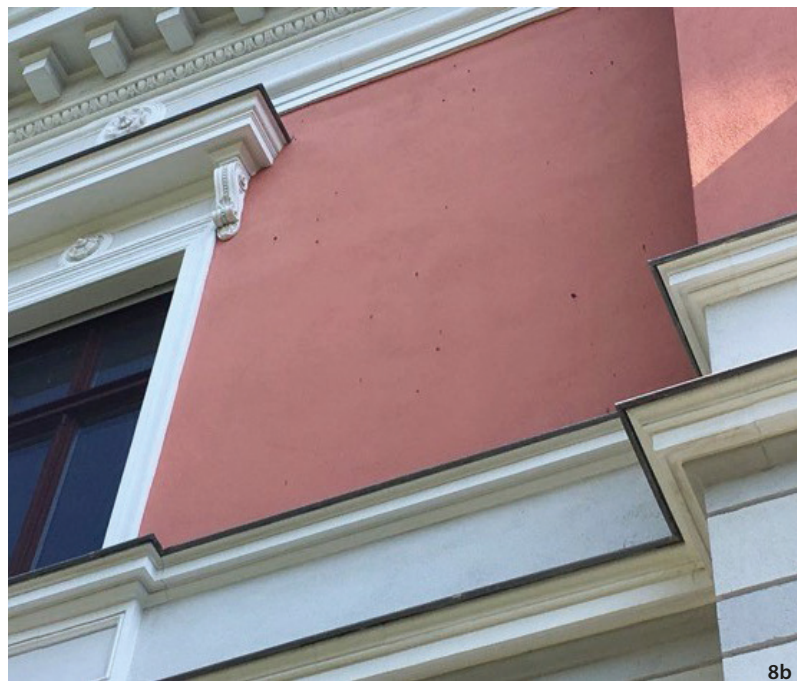
Figure 8 Pictures of Classicist Villa, Park Street, Wiesbaden, Germany, in 2018; 20 years after restoration with lime plaster and red-coloured lime paints (Source: the author).

20 years ago, plaster over the entire façade of the Classicist Villa was visibly detached. There was clearly a lack of adhesion of the painted top coat, which had a thickness of 0.5–1 cm; that was above soft lime mortar, which had a thickness of about 2 cm. The underlying masonry was brickwork covered with lime mortar.

Following preliminary examinations and tests, restoration was undertaken. The efforts were successful, and the Classicist Villa is now in good condition. The entire exterior façade, including the base area, was re-plastered using a lime plaster and then painted with a lime-based paint to match the lime mortar. The new pink lime-based paint has helped preserve the building (Figure 8).

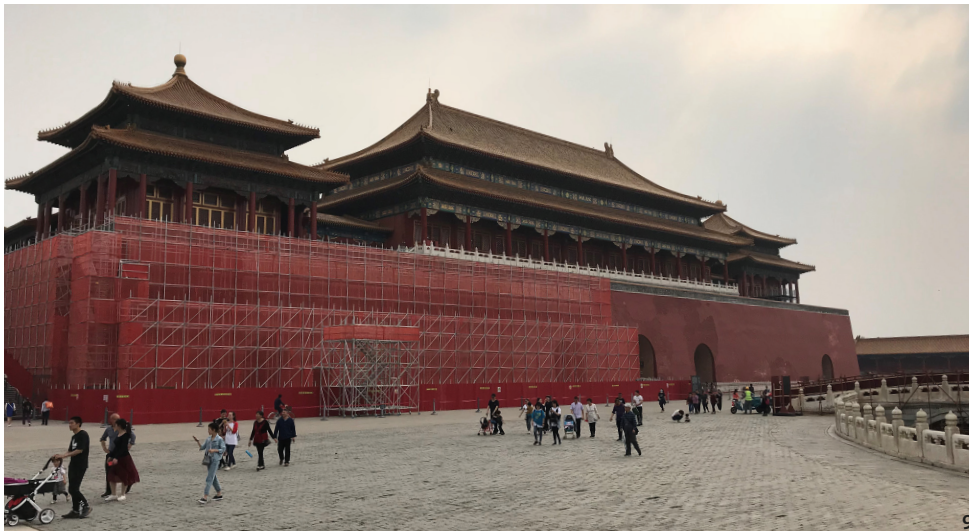
Figure 9 Lime plaster maintenance for Wu Men (Meridian Gate) of the Palace Museum in Beijing during the summer 2018 (Source: the author).

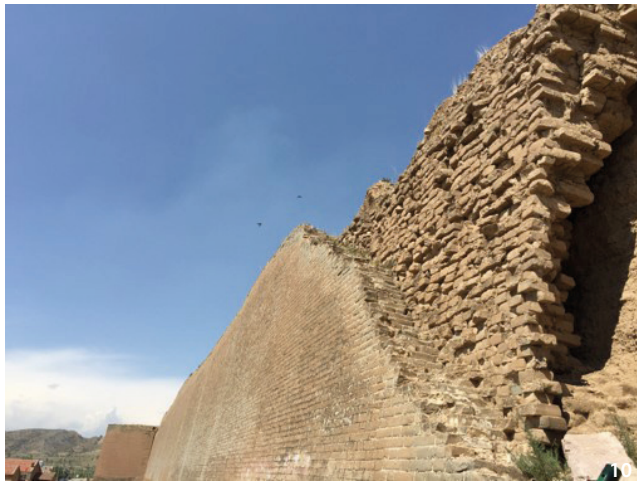
Figure 10 Ruins of the Great Wall in Zhangjiakou, Hebei Province, constructed with dolomitic lime (Source: the author).

From the results of joint investigations, it has been found that at least some parts of the Great Wall of China, built in the Ming Dynasty, were constructed using dolomitic lime (Figure 10). That kind of lime is not very durable—especially in the industrial climate of the modern age (IFS 2003). Scientific studies of dolomitic lime have helped clarify why the Great Wall has suffered severe damage in recent decades owing to the increase in industrial SO_2 and NO_x emissions. Conserving such an architectural heritage is a matter of particular concern.

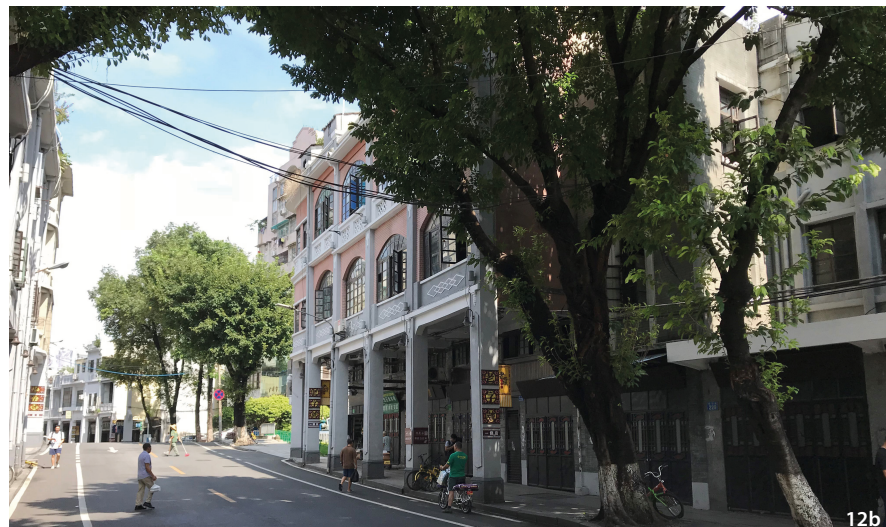
Figure 12 Documentation of building archaeological work to reveal historic plastering technique during the redevelopment of Enning Road in Guangzhou in January 2019 (Source: the author).

In a historic urban landscape, traditional plasters are character-defining architectural elements. Conservation redevelopment of Enning Road in Guangzhou began in 2018. Using building archeological and documentation methods, a German–Chinese group studied the road's historical plasters (Figure 12). This kind of

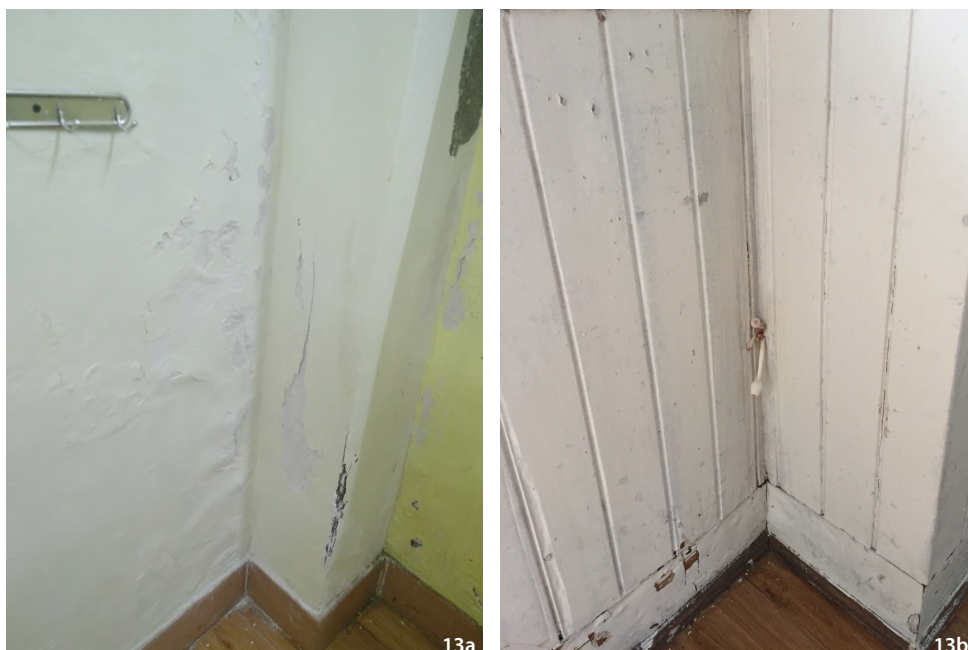
Figure 13 Defects in one kindergarten in Hangzhou, which may cause severe health risks, need a special solution (Source: the author).

Revitalising the use of traditional materials and building techniques for renovation or for application in modern constructions involves challenges. The defects observed in one building used as a kindergarten in Hangzhou show that conventional cement plaster does not work when used with masonry contaminated with salts under conditions of extreme humidity (Figure 13). To deal with this situation, a new plaster system based on functional rendering using lime plaster and lime wash is being developed under the Elite Innovation Program (2015) of Huzhou Municipal Government, Zhejiang Province of China.
