# Sacrificial Protection for Architectural Heritage Conservation and Preliminary Approaches to Restore Historic Fair-Faced Brick Façades in China

**ABSTRACT** Sacrificial protection is a kind of active preventive intervention to conserve authentic fabric of architectural heritage, especially surfaces. This paper investigates the term of sacrificial protection and technical options, summarising that sacrificial plasters, shelter coating and plastic repair or re-pointing are three proven sacrificial protection measurements to conserve architectural surfaces. Two case studies show the preliminary approaches with help of sacrificial protection concept to restore historic fair-faced brick façades in China. Sacrificial protection concept did not originate from Chinese conservation practices, but it provides new prospects for sustainable conservation and revitalisation of architectural heritage. The implementation of sacrificial protection is still limited and more scientific studies are needed although most of approaches are traditional.

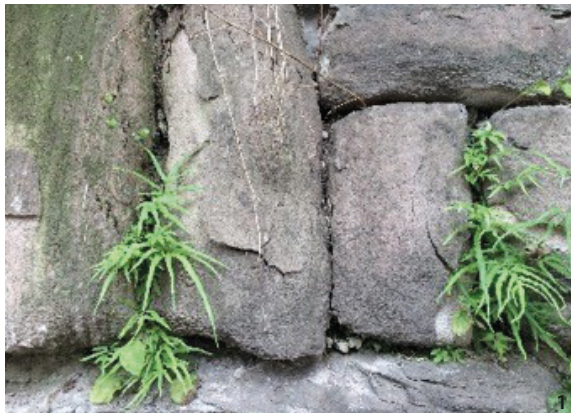
**Figure 1** Sandstone of the former city wall in Chongqing built in Ming Dynasty, impregnated by methyl silicates and water repellents and peeled after 15 years later (Source: the author).

even became worse, for the chemical emission increased in the past two decades. The seepage water together with air-born pollution accumulates under the border between treated hydrophobic zone and hydrophilic substrate, which causes disastrous material losses after one decade.

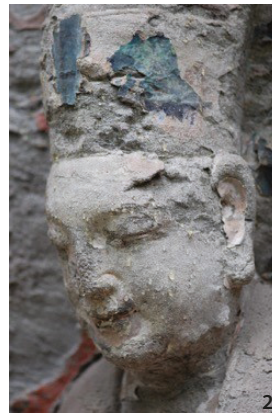
**Figure 2** Condensation on the surface of a Buddha figure which is well sheltered against precipitation (Source: the author).

Another factor for the damages of monuments and buildings is condensation, which can hardly be eliminated and occurs often within or on the surface of monuments (Figure 2) and building envelopes. Few researches indicate the impacts of highly  $\text{SO}_2$ ,  $\text{NO}_x$  polluted air on condensation, but visual observation shows it can cause severe damage, and yellow drops of water are probably of good evidence.

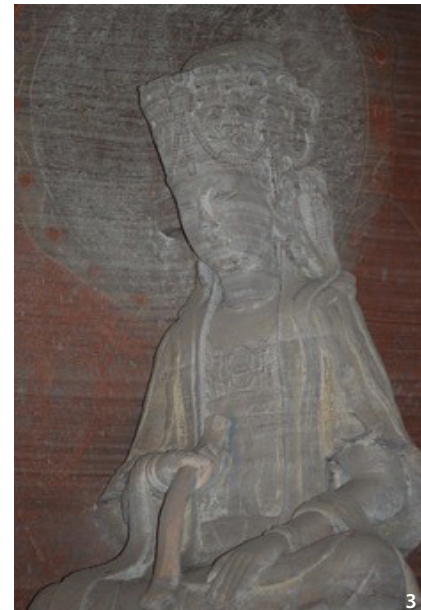
**Figure 3** Fading of mural painting and accelerated stone deterioration of Buddha figure approximately 20 years after a so called 'environmental control measures', according to oral report of Fangying Li 2018 (Source: the author).

In the past, some conservation practitioners tried to optimise the environmental conditions, for example, to lower the moisture level of grottoes of some cave temples, but these experiences ended up tragically in an unexpected manner. For example, existing mural paintings on the stone surface of cave temples faded much faster (Figure 3) after the ground water level had been dramatically lowered.

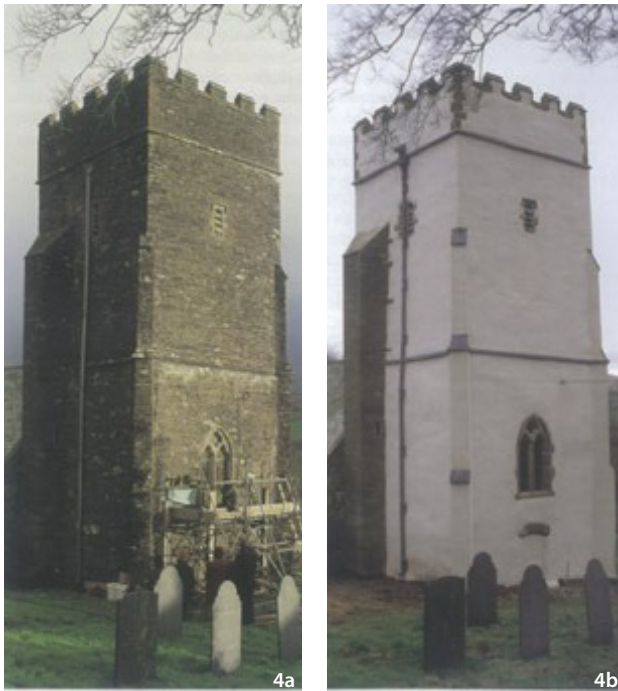
**Figure 4** Holy Trinity Church, North Devon in 1994 (4a) and 1998 (4b) (Source: *English Heritage: Mortars, Renders & Plaster*, 2011).

Since 2010, it has almost become a standard recommendation to coat heavily salt-laden wall with sacrificial plasters in England (Figure 4). ‘Such plasters should be designed to be weaker and more permeable than their substrate and fail sacrificially’ (Henry and Stewart 2011, 211–212). In Germany, there are practices intentionally using sacrificial plaster from the 1990s (Auras, Meinhardt and Snethlage 2011; Dettmering and Kollman 2011). The physical performances can be optimised by using various binders (Hilbert 1995). In 2006 a guideline on sacrificial plaster (Merkblatt 2-10-06/D, Opferputze) was published in Germany.

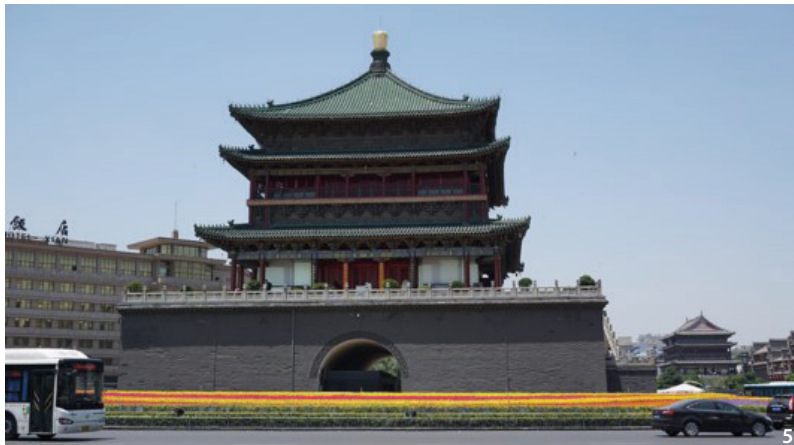
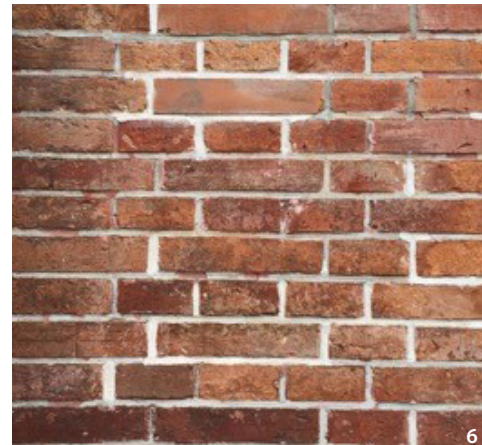
**Figure 5** Xi'an Bell Tower, 2016. Actually, the masonry walls are covered with a very thin coat with thickness between plaster and coating and the original surface has been changed, however the thin coat has not been well designed as a protection layer and four walls have a very severe salt problem (Source: Yan Zhong).

The concept of sacrificial protection is becoming more practically accepted in China. ‘Mobiheritage’ (a Wechat official Account in China) reported to use sacrificial material based on natural hydraulic lime instead of cement for the Guyue Bridge restoration in Yiwu, Zhejiang Province, China. However, in China we are confronted with a problem that the original appearance of architectural heritage or monuments is not allowed to change, according the approved principles. Thus we are stuck in an awkward situation when answering a question like how to protect a historic masonry wall if it is exposed fully to a heavy traffic surrounding environment? (Figure 5)

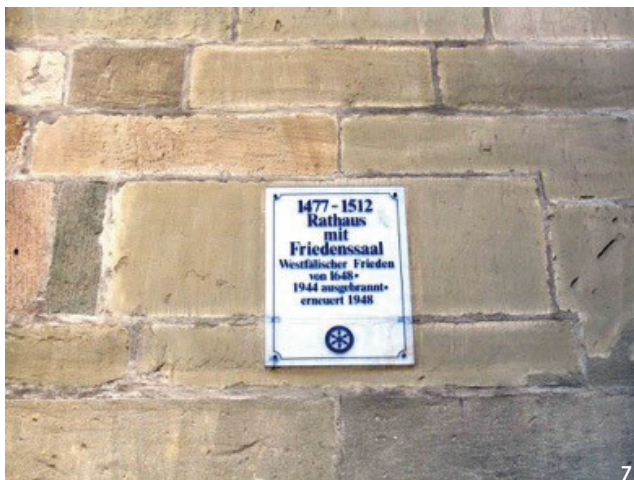
**Figure 6** Plastic repair and lime pointing as sacrificial measure (Source: the author).

bricks. The plastic repair mortar shall be free of harmful water soluble salts. The pointing mortars shall be even more less durable than repair mortars and shall be sacrificed first during the service lifespan of the restored architecture (Figure 6).

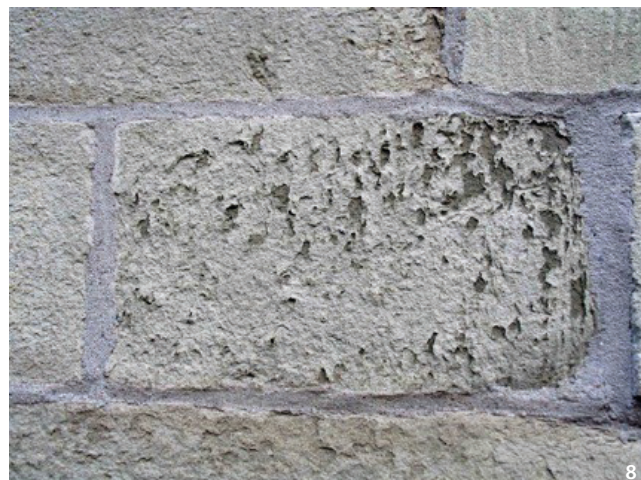
**Figure 7** Partial view of the eastern exterior wall about 1 m wide. After the latest restoration in 1983–1985, the façade stays in a satisfactory state of preservation during almost 25 years (Source: Auras, Meinhardt and Snethlage, 2011).

A good case is the use of silicate and silicone emulsion coatings on the red melle sandstone façade during 1983–1985, which stay on the stone surface instead of being absorbed into pore space like other coating materials. It has been proven that the coating protects well the original façade from weathering (Figure 7, Figure 8) (Auras, Meinhardt and Snethlage 2011).

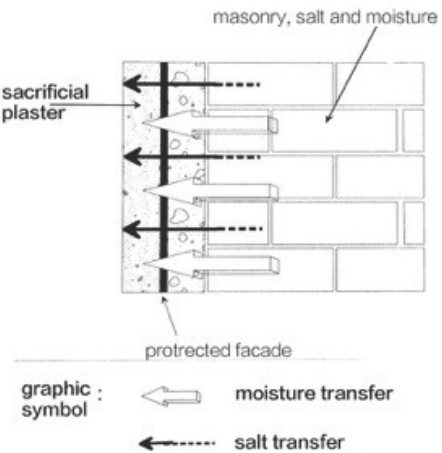
<p>masonry, salt and moisture</p> <p>sacrificial plaster</p> <p>protected facade</p> <p>graphic symbol :   ← moisture transfer  ←····· salt transfer</p>

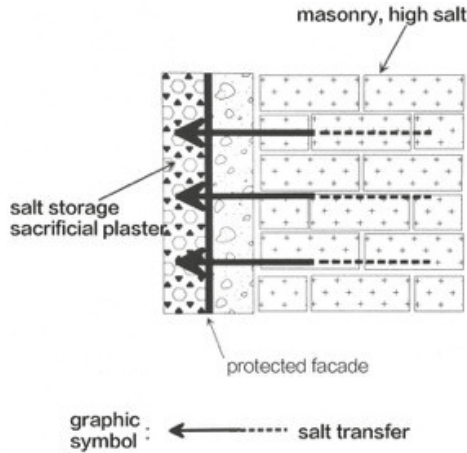
<p>masonry, high salt</p> <p>salt storage sacrificial plaster</p> <p>protected facade</p> <p>graphic symbol : ←····· salt transfer</p>
OP-I-Moisture	OP-A

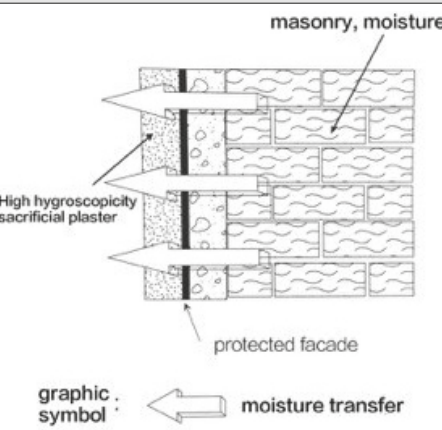
<p>masonry, moisture</p> <p>High hygroscopicity sacrificial plaster</p> <p>protected facade</p> <p>graphic symbol : ← moisture transfer</p>

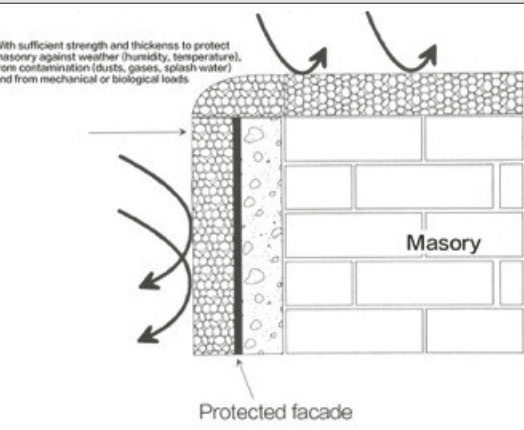
<p>With sufficient strength and thickness to protect masonry against weather (humidity, temperature), from contamination (dusts, gases, splash water) and from mechanical or biological loads.</p> <p>Masonry</p> <p>Protected facade</p>

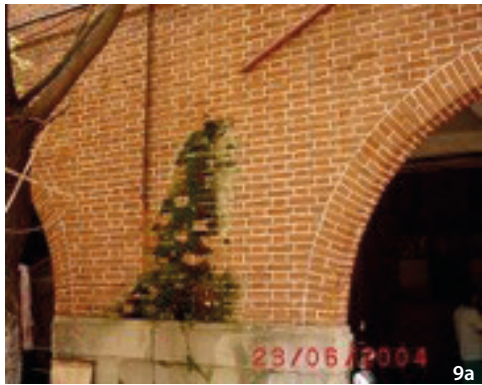
**Figure 9** Fair faced brick façade of Jiangwan Stadium before restoration (Source: the author).

As monument and remarkable heritage architecture, it was restored during 2004–2005. The fair-faced brick façade, totally over 20,000 m<sup>2</sup>, was one of the most important challenges for conservation works (Figure 9), because it was painted and suffered from heavy damages by rain water and improper usage.

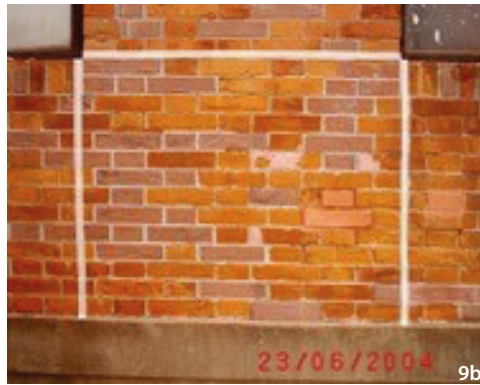
**Figure 10** Restoration measures of different bricks (Source: the author).

3. Old bricks were classified into four categories according to their visual deterioration patterns (Figure 10).

Category 1: bricks without any visual deterioration: preservation without any intervention beside water repellent treatment.

Category 2: bricks with obvious deterioration, but the materials loss is less than 5 mm: preservation with treatment of ethyl silicate and solvent based water repellents.

Category 3: bricks with visual deterioration but the materials loss is less than 25 mm, consolidation with ethyl silicate and repair with special consolidation mortars (plastic repair mortar, also called brick powder).

Category 4: bricks with visual deterioration, the materials loss more than 25 mm: replaced by old healthy brick.

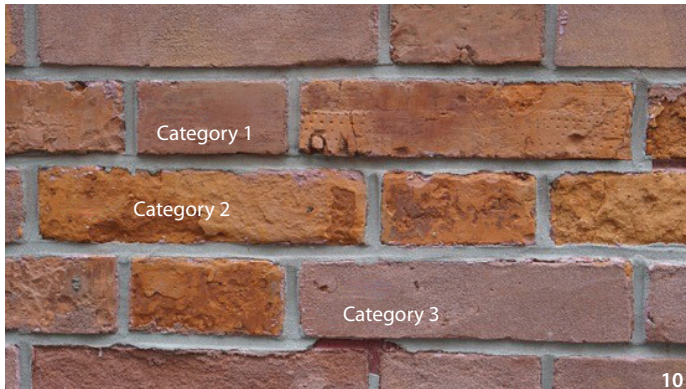
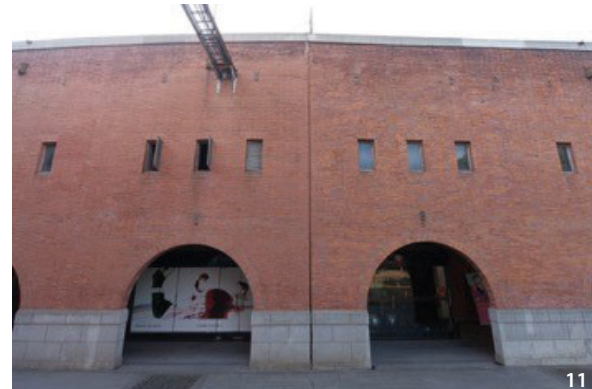
**Figure 11** Bricks 12 years after restoration in Jiangwan Stadium, October 2016 (Source: Liu Yuhan).

11 years after restoration, a visual inspection has been done by the author in October 2016. The façade of the Stadium itself was in good condition (Figure 11), but some bricks showed severe defects, which can be summarised as follows:

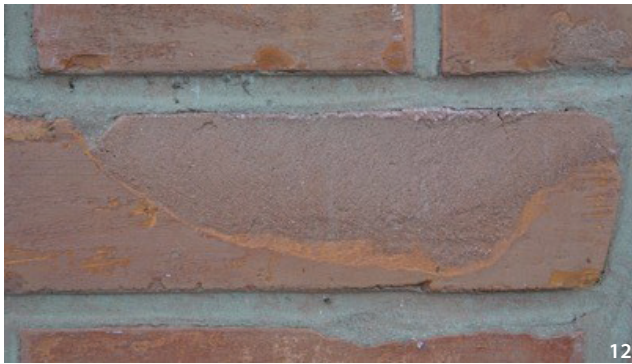
**Figure 12** Attack by restoration plaster (Source: the author).

1. The strength of the new repair mortars seemed to be weaker than the old bricks, but there are some ‘attacks’ from repair mortars (Figure 12). This kind of ‘attacks’ may be caused by water soluble salts which existed in the cement-based repair mortar.
2. The pointing mortar seemed to be much stronger than repair mortar, although in most areas the joints were intact.
3. The consolidation with ethyl silicate may have contributed to the peeling or spalling of slightly deteriorated bricks (Figure 13). This could be caused by salts, high moisture content of the brick substrate or too low application rate. There were obvious efflorescences, but desalination had not been considered within the specification.
4. Some spalling of original brick needs to be further studied.

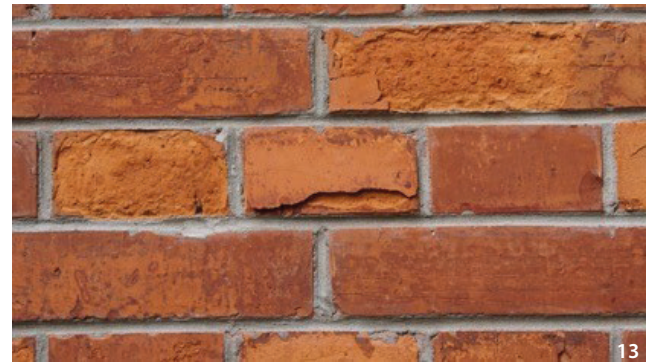
**Figure 13** Delamination of old bricks after consolidation with ethyl silicate, the spalling may be related to frost (Source: the author).

The consolidation of with ethyl silicate might have reached less success due to substrate conditions are far more complicated than in the laboratory.

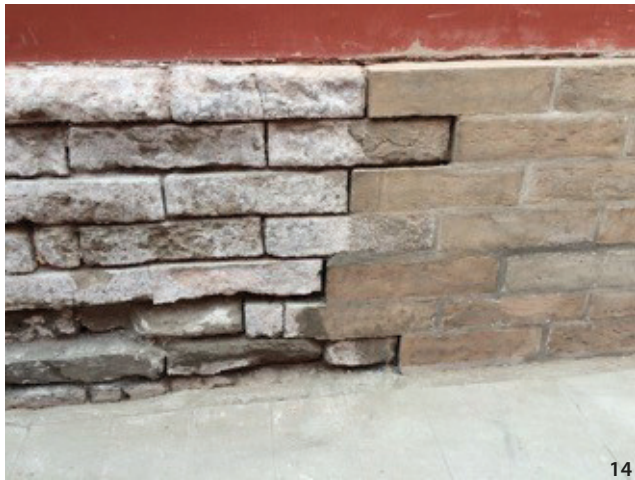
**Figure 14** Ongoing restoration work in Beijing (2016), grey brick with high concentration of salts (most of them are gypsum and potassium nitrate) (Source: the author).

Because most of the brick façades in northern China had been deathly restored (Figure 14), i.e. the lively brick façade looks dead after restoration using replacement, a comprehensive research project, ‘Conservation of Historic Brick Masonry in Arid Region’, started in 2015 under the leadership of Shaanxi Provincial Institute of Cultural Heritage and Tongji University. This national research project was financially supported by the China National Cultural Bureau. Within the research framework, a ‘sacrificial restoration’ material system was developed to conserve historic masonry especially grey brick work in arid region. ‘Sacrificial’ has been officially used because it was deemed the most accurate way to explain the requirements to meet the principle ‘repair rather than replacement’.

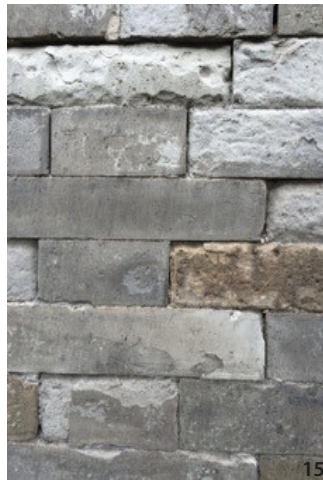
**Figure 15** Typical deterioration of bricks of Dayan Pagoda (Source: the author).

The typical deterioration of the bricks in Great Wild Goose Pagoda is discoloration, powdering and peeling of bricks (Figure 15). The colour of grey bricks turns darker near the foundation or along eaves. The current maintenance method is to replace deteriorated bricks by new one.

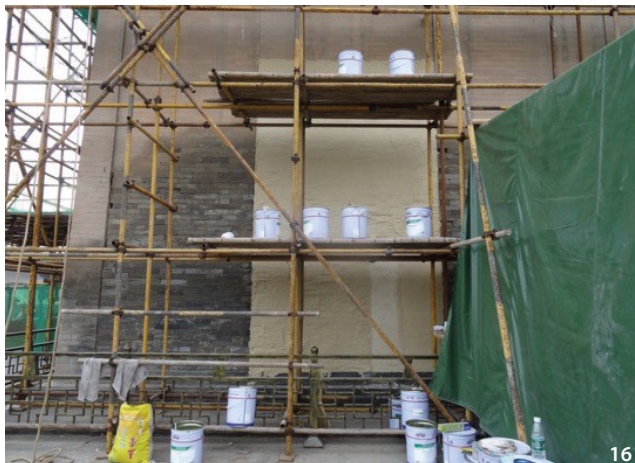
**Figure 16** Application of sacrificial materials on site (Source: the author).

After evaluation and laboratory testing, three types of sacrificial materials have been developed. The first one is desalination poultice based on clay minerals and paper fibres without any lime or organic binder. The second material is the repair mortar based on natural hydraulic lime (NHL) instead of cement. The third one is the pointing mortar based on a mixture binder of air lime (CL) and natural hydraulic lime.

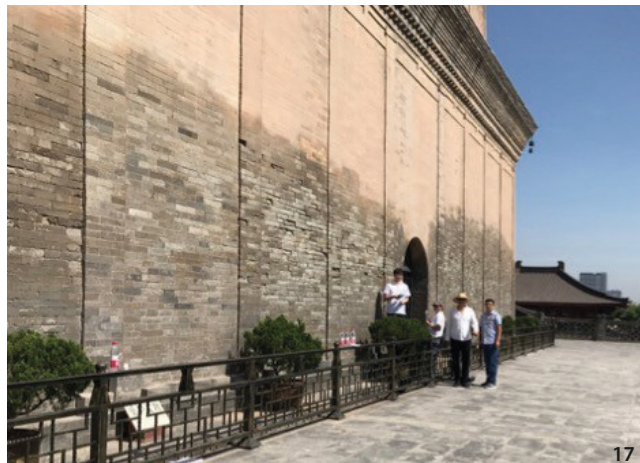
**Figure 17** One year after the restoration test of fair-faced brick wall of Dayan Pagoda in Xi'an under the research framework of the China National Cultural Bureau (Source: the author).

The trial area has been completed in the summer of 2016 and will be monitored and evaluated before any further intervention or implementation to other areas.
