Understanding of the settlements with coexisting water and earth under the background of climate change—the case of Liang Village in Pingyao County, China

Yong Shao*, Yue Chen and Jianming Su

Abstract

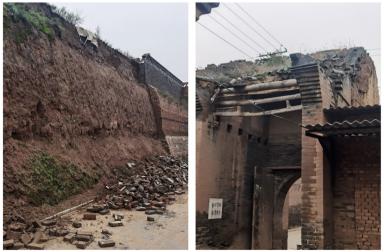
Fig. 3 Collapse of village wall and door roof of Liang Village (Source: Pingyao County government)

very vulnerable when meeting 'water'. Many earthen built heritage sites in this region were severely affected, seriously damaged, and even partially collapsed. In Liang Village, village walls and door roofs had collapsed; although some materials were not earth, they were also damaged by the loss of earth as filling material (Fig. 3).

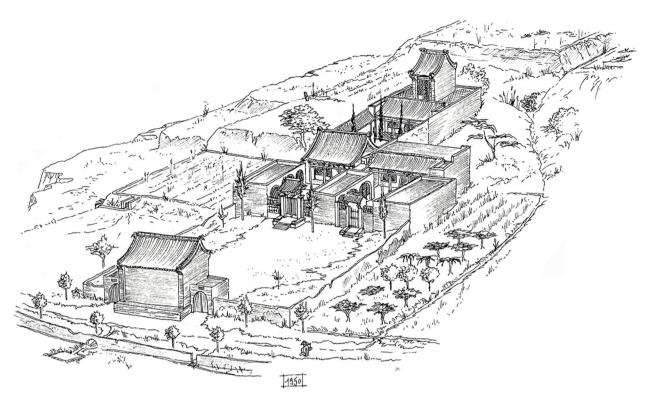
Fig. 9 Layout of Yuanshen Temple (Source: Tongji University and Ecole de Chaillot 2010)

it, they named it 'Shen Quan' (神泉, means 'sacred spring'), built a fence to protect the outlets of the spring, and even established a temple, 'Yuanshen Temple' (源神祠, means temple for the god of water), on the east side to sacrifice to the god of water. The Yuanshen Temple was located between the fields amid the stage and the wells, taking the natural mountains and water systems as its background, underscoring the history of the endless awe and prayers for water sources among the villagers (Figs. 7 and 9).

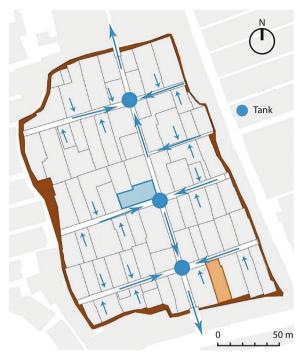
Fig. 10 Rainwater collection and storage system in Nanqian Bu (Source: Tongji University and Ecole de Chaillot 2010)

First, the ancestors carefully built a rainwater storage system in the village. The rainwater collection port and passages were well preserved on the top of the 'Bu' walls. Fishbone streets and lanes with a certain slope also had water passages. Rainwater went through the streets, collected in the tanks under the central street, the lowest place in the village, and was stored for daily use. It was very important in dry seasons or in defensive situations. Even today, while the original wells and underground aquifers have dried up, this water collection system can still be used. This was the elastic mechanism that Liang villagers created in response to their arid climate (Fig. 10).

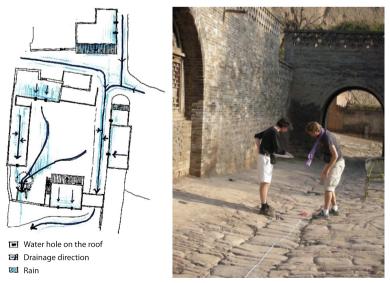
Fig. 11 Topographic microprocessing in the stage square and underground rainwater collection and drain systems (Source: Tongji University and Ecole de Chaillot 2010)

drainage. Liang Village Stage Square was not only very secluded in terms of the treatment of the microterrain in accordance with the relationship between the opera stage, stand and the square but also excellent at collecting rainwater and then draining it out of the square quickly via its natural slope (Fig. 11).

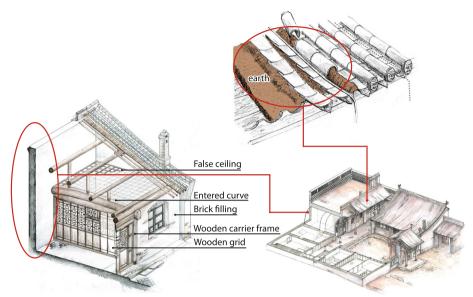
Fig. 12 Earthen material and the detailed treatment to prevent rainwater in Shanxi residential architectures (Source: Tongji University and Ecole de Chaillot 2012)

Limited by local conditions, traditional buildings were made of local materials, such as earth and bricks, which had the unique effect of warming in winter and cooling in summer and reflected the unique local characteristics and a typical vernacular architecture. There were three main types of local buildings, almost all of which used earth as the main building material. The first was Yaodong, which leaned against mountains and made use of earth directly. The second was the independent Yaodong, which could be built widely on flat ground, the upper layer of which was covered with earth. The third type was a brick house, the walls of which were mostly adobe with a roof with a thick earthen layer. To protect this earthen layer from rainwater, tiles were used to drain water quickly (Fig. 12). Except for the residential buildings, other architectural elements in the settlement, such as the gate and the 'Bu' walls, were mainly built of earth and were also treated in detail to make rainwater flow quickly and prevent erosion.

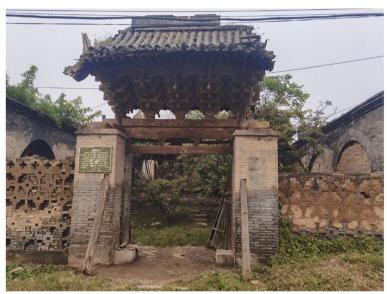
Fig. 14 Yuanshen Temple after the flood (Source: the author)

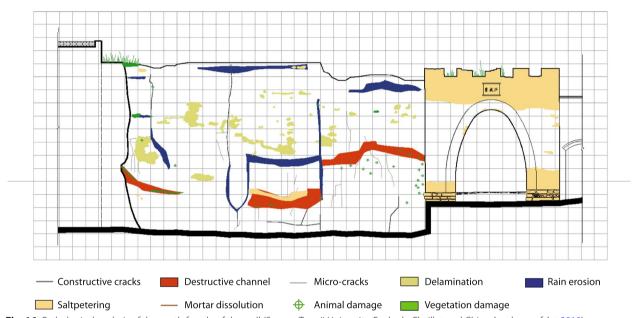
Fig. 16 Pathological analysis of the south facade of the wall (Source: Tongji University, Ecole de Chaillot and China Academy of Art 2010)

For earthen materials, the greatest threat has come from water vapour, which has caused cracks, spalling, ravines, flooding and other common pathologies due to rainfall and humidity. Regarding the wall on the south side of Xining Bu in Liang Village, for example, after years of erosion, the drainage system was especially destroyed, and the wall was seriously damaged. There were thus many structural pathologies, such as structural cracks, destructive gullies, overturning and settlement, and more surface pathologies, such as microcracks, spalling, scouring gullies, alkalisation and plaster loss, in the wall (Figs. 15, 16 and 17).

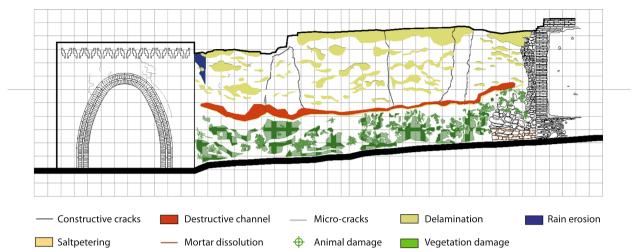
Fig. 17 Pathological analysis of the north facade of the wall (Source: Tongji University, Ecole de Chaillot and China Academy of Art 2010)

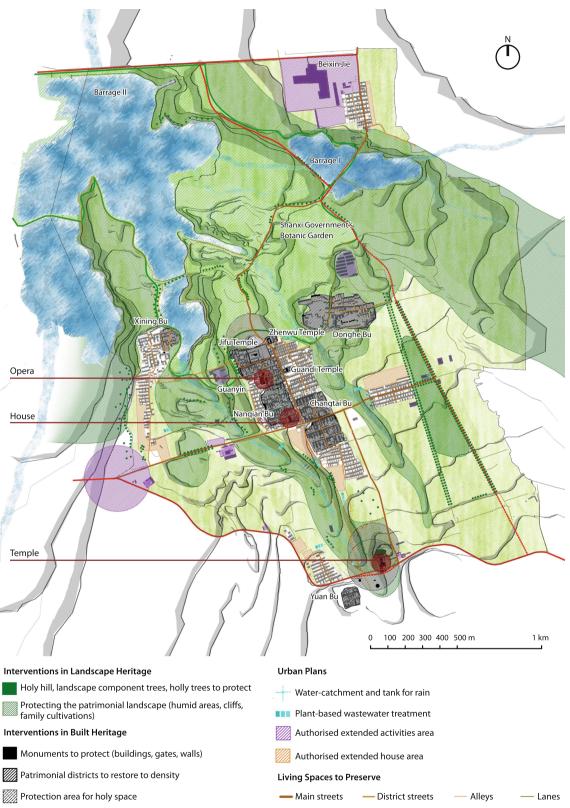
Fig. 18 Conservation and development plan of Liang Village (Source: Tongji University and Ecole de Chaillot 2010)

According to the traditional characteristics of Liang Village, such as following *fengshui* theory and considering security and defence, as well as its current heritage distribution features, the conservation and development plan of Liang Village was proposed. There were several strategies in the plan, such as the delimitation of the ecological protection areas, the built heritage protection areas and the areas where construction would be conditionally permitted. The target of these strategies was to protect the spatial order and spatial pattern with the characteristics of 'living on the terrace and farming in the valley' in Liang Village (Fig. 18).

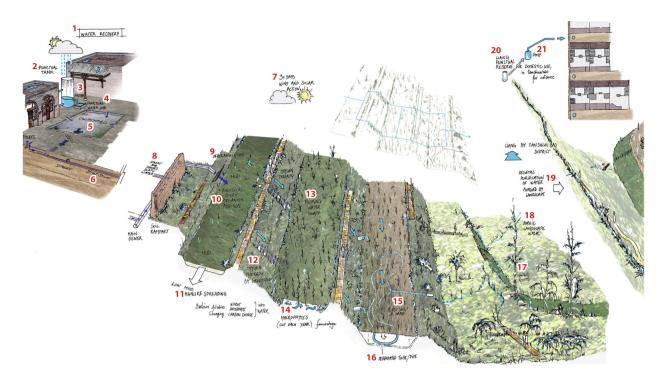
- 1 water recovery
- 2 punctual tank
- 3 filter
- 4 punctual water use
- 5 courtyard
- 6 street sewer
- 7 30 days wind and solar action
- 8 street and houses dirty water
- 9 degranulation
- 10 biological microorganism addition
- 11 Low-mud manure spreading
- 12 oxygen therapy by gravitation
- 13 filtering water swamp
- 14 macrophytes (cut each year) faucardage
- 15 mixed soil and sand
- 16 perforated tube/pipe

- 17 willow roots
- 18 public landscape walk
- 9 vegetal purification of water purged by landscape
- 20 Liang punctual reserve for domestic use, in Tianshun Bu for instance
- 21 pump

To improve the drought environment and thus to enhance the resilience of the village to cope with natural disasters that may occur again in the future, the remaining water conservancy facilities and irrigation system were rearranged. Initially, rainwater would be collected and filtered for daily use by the villagers. The domestic wastewater, once used, would flow to the fields. Through ingenious terrain treatment and pipe arrangement, the wastewater should be fully utilised for plant irrigation. Meanwhile, the excess water will be refiltered by the ecological purification function of plants, such as reeds, and finally returned to the village for daily use by the residents; thus, a water circulation system could be established. To protect the surface runoff, we also suggested building a plank road system in the valley that would be fully integrated with terrain (Fig. 19).

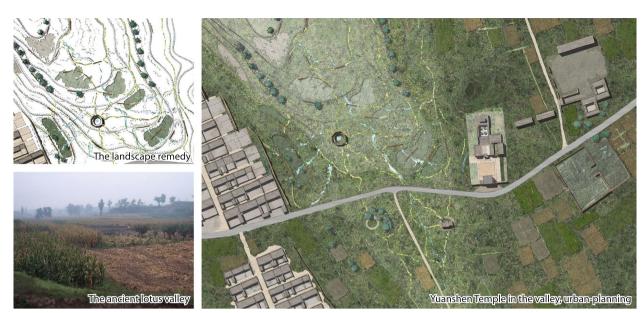
Fig. 20 Landscape restoration (Source: Tongji University and Ecole de Chaillot 2010)

between people, god and nature through landscape restoration. First, the traffic road that separates the temple and stage should be diverted from the south of the stage to recover the original integrated layout of the temple. Second, more green plants should be added around the water source to gradually form a good ecological environment. Last, Yuanshen Temple should fulfil new functions as a public facility for ecological restoration with planned exhibitions, cultural tourism and management. Although it does not retain its original sacrificial function, the temple can allow people to gain respect for nature, restoring the power and wisdom of the balance between man and nature (Fig. 20).

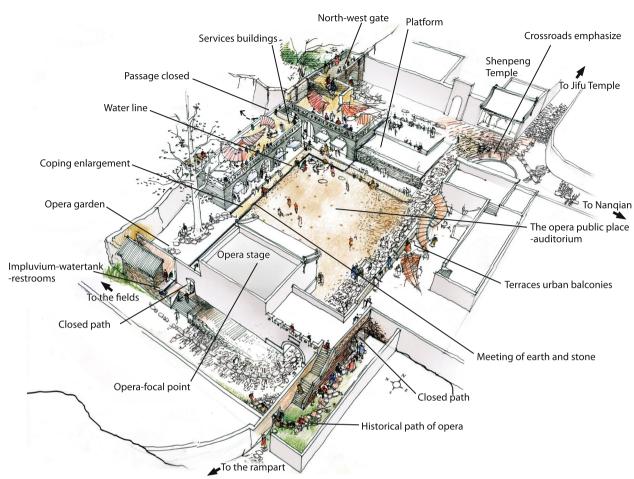
Fig. 21 Regeneration of the stage square and recovery of the microterrain (Source: Tongji University and Ecole de Chaillot 2010)

Specifically, the northwest gate, the affiliated buildings and the detailed paintings needed to be repaired to strengthen the central position of the stage and to foster the cultural functions of watching and performing to revive the centre of the village. Meanwhile, to recover the original drain system, it was also necessary to repair the microterrain of the square because some terrain has been artificially altered and would easily block water (Fig. 21).

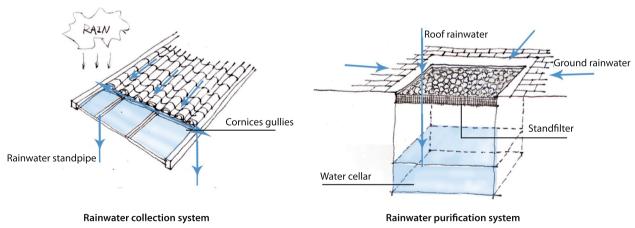
Fig. 22 Rainwater collection system for traditional residential buildings (Source: Tongji University and Ecole de Chaillot 2010)

The rainwater collection system inside the village needed to be repaired and strengthened to improve the village's ability to cope with extreme climates. Moreover, the village's microclimate needed to be adjusted through water circulation to create a more liveable environment for the residents (Fig. 22).

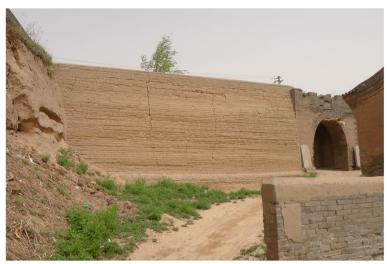
Fig. 23 The effect of the wall after restoration (Source: the author)

For earthen material, the core target was to decrease the threat from water vapour. Taking the wall on the south side of Xining Bu in Liang Village as an example, the workshop team made several efforts to realise this Shao et al. Built Heritage (2022) 6:22 Page 17 of 20

target. First, they planned to restore the underground drainage system before repairing the body of the wall. Then, to increase the strength of the material, they chose to add lime or rice slurry but not cement, which is impermeable and may adversely introduce more vapour into the earth.

After the workshop, the local authority carefully considered the suggestions from the workshop team and immediately implemented two restoration projects: the wall on the south side of Xining Bu and the damaged stage square drainage system. The core of these two restorations was to deal with the relationship between water and earth. The key to the former project was to dredge the underground drainage system so that the water vapour could be discharged without damaging the wall, while the key to the latter was to adjust the terrain so that the rainwater could drain quickly without clogging. The effects of these two projects have been excellent; not only have the structures remained in good condition for 10 years but they also avoided any damage from the flood disaster in 2021 (Figs. 23 and 24).

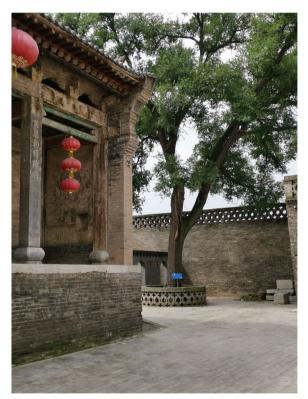
Fig. 24 The status of the stage square after the 2021 flood (Source: the author)
