Colourful treasure on Shanghai's Bund: uncovering original paint finishes in the Chinese Banking Hall of the former HSBC Building

The former HSBC Building, today occupied by Shanghai Pudong Development Bank, is one of the largest iconic buildings on the Bund in Shanghai. Designed by Palmer & Turner in the neoclassic style, the building was completed in 1923. Restoration of the interior of the Chinese Banking Hall, located within the southwestern corner of the building, is now underway. This rectangular room features four columns in the centre and stucco decoration on parts of the walls; the ceiling originally had a distinctive, vibrantly colourful design in a bold mix of Western and Chinese styles. The only extant documentation of the banking hall's original decoration includes black-and-white photographs and a short, written description. Today, all the plaster surfaces are covered over with several layers of white and cream-coloured paint finishes. A preliminary analysis of the hall's decorative finishes was conducted to determine the colours, paint materials, and condition of the original paint layers. The investigation revealed that in some sections, the original paint was very

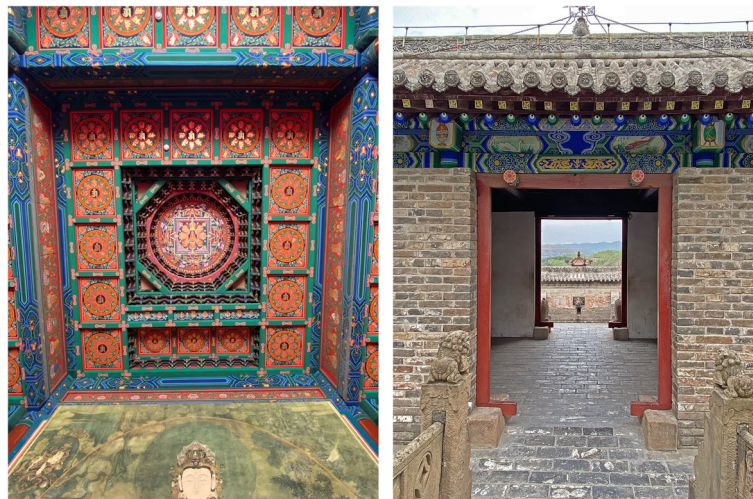
Fig. 1 Examples of typical *caihua* decoration on ceiling panels, wooden beams, and eaves, here apparently recently renovated. Left: Fahai Temple, Shijingshan District, Beijing. Right: Baiyunshan Temple complex, Jiaxian County, Yulin, Shaanxi Province (Source: the author)

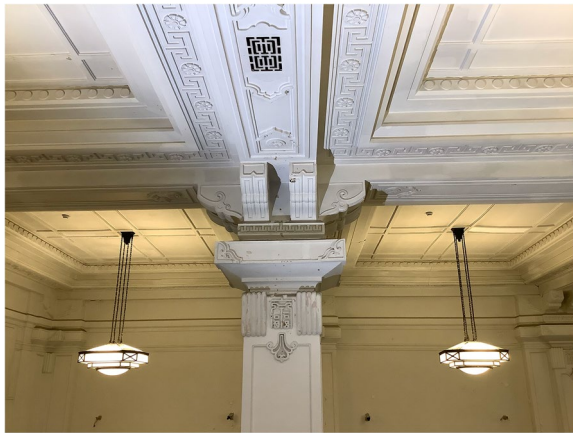
The Chinese Banking Hall is a rectangular room situated in the southwest of the ground floor. The hall's ceiling is divided into nine large coffer panels with four central columns and corresponding pilasters separating the sidewalls of the hall. Today, the columns and ceiling are present as white stucco decorations (Fig. 3);

Fig. 3 Today, the ceiling of the banking hall is covered in several layers of paint, and the currently visible finish features a matte-white acrylic dispersion paint. (Source: the author)

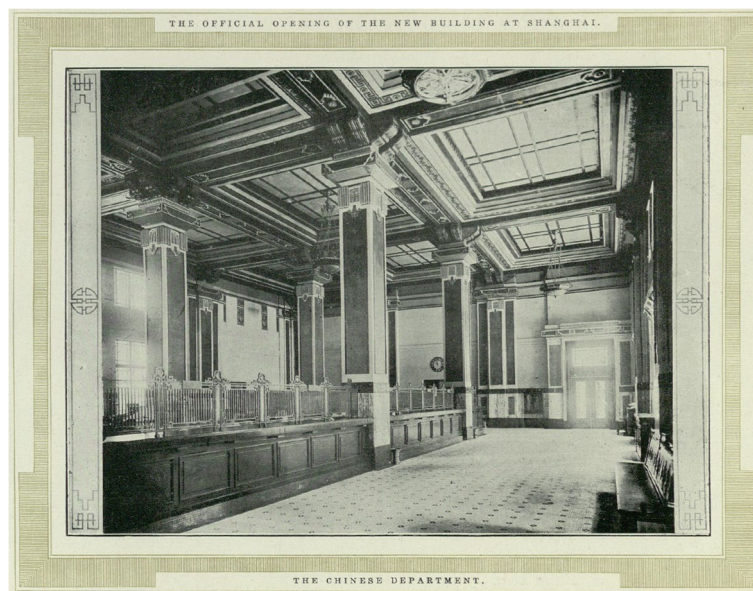
Despite being black-and-white images, the photographs in the brochure further document the colour accentuation of the former interior decoration (Fig. 4). The original room design is considered to be of high aesthetic value in terms of its vibrant, bold colour use and combination of Chinese and Western design and decoration. Today, the vibrant colours of the walls and ceiling are covered in several layers of white and cream finishes, but the original paint remains beneath the modern finishes—as confirmed by the following investigation.

Fig. 4 The Chinese Banking Hall from the original pamphlet of the opening ceremony of the HSBC Bank in 1923. (Source: "The Hong Kong and Shanghai Banking Corporation", 1923. Reproduced with the permission of HSBC Holdings plc)

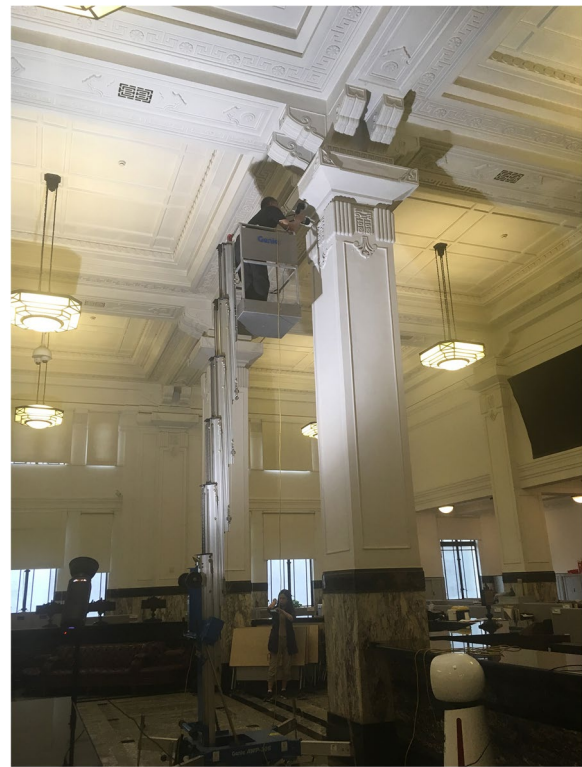
The interior decoration of representative sections of the walls and ceiling was investigated in situ using a lift crane (Fig. 5); covering layers of paint were removed by scalpel after softening the area with a biodegradable water-based paint remover (BioLine Eastrip produced by Shanghai DS Building Materials Co., Ltd., China). Openings of approximately 1–5 cm² were prepared and standard colour tones were defined by comparison with an Natural Color System (NCS) color chart (see Sect. 3.4).

Fig. 5 On-site investigation of finishes and sampling conducted using a lift crane. (Source: the author)

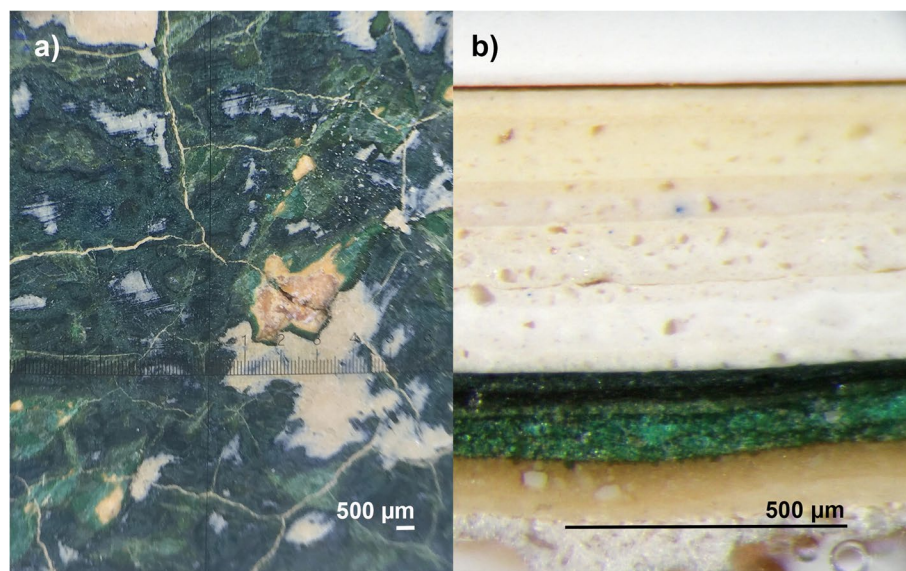
Fig. 6 **a** Detail seen through a magnifying glass, showing the original green paint layer exposed at the site. Where the upper darker finish was scratched off during exposure, the brighter, intense-green lower layer became visible. **b** Photomicrograph of a polished cross section of the same green colour layers. (Source: the author)

Visual observation of the cross sections under the stereo microscope showed a primer layer upon the smoothed plaster finish. The decorative paint layer was applied onto the plaster by first applying that primer, then a cream-beige base coat, followed by two to three colourful painted layers, as noted above. The colour finishes have very fine texture. They are followed by several layers of white, beige, and cream finishes (Figs. 6b, 7).

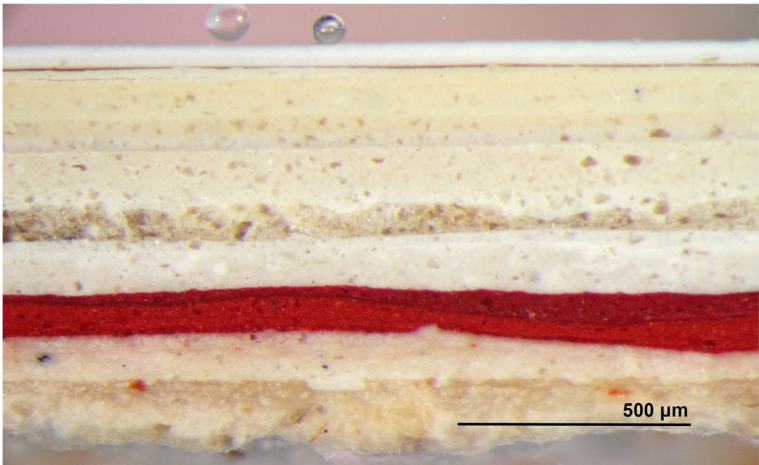
Fig. 7 Polished cross section of the paint stratigraphy: the top white finish is the currently visible paint finish; the red layer with ground and primer is the original paint layer, which was covered by several cream and white finishes at later stages. (Source: the author)

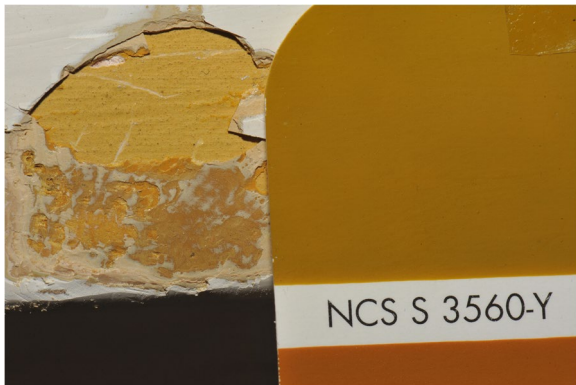
The five main base colours mentioned above were further identified with respect to hue, saturation, and blackness by visual comparison and recorded by matching them with the closest NCS colour (Fig. 8). Together with the

Fig. 8 Magnified detail of the yellow paint layer (opening approximately 30 mm wide). The darker tone in the lower part of the opening is the original finish. (Source: photograph reproduced with the permission of Zhong Tang)

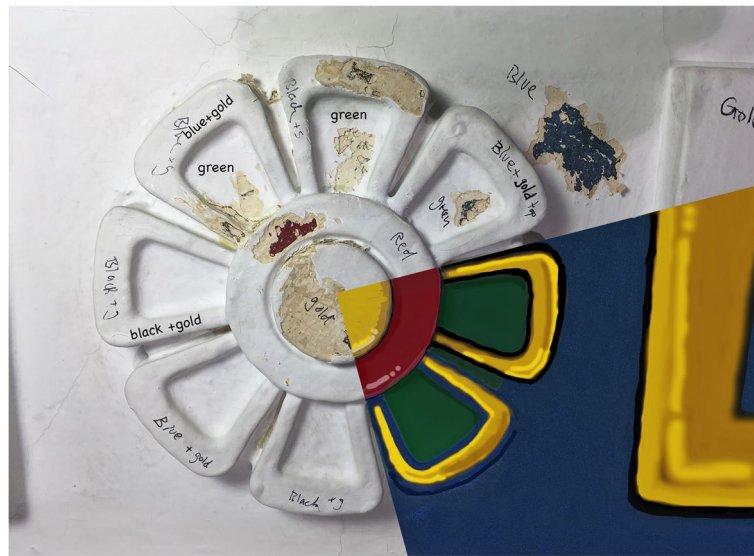
and blue. Green and blue, with small accents in red and gilded highlights, were used for decorations that resembled Greek meanders and flowers (Fig. 9). Figure 10 shows a detail of the ceiling montaged with watercolours and presents a schematic representation for the colour distribution; it is simplified to five tones, which roughly match the original colours.

Fig. 9 Detail of ceiling decoration (flower in the meander band around the main ceiling panels), indicating the colour scheme on-site and illustrated digitally. (Source: the author)

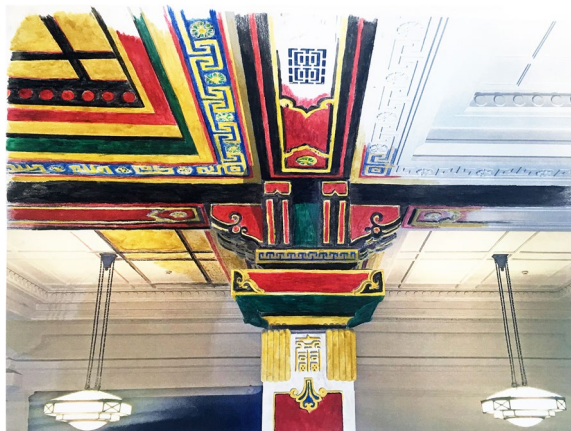
Fig. 10 The Chinese Banking Hall with a montage of the coloured decoration to visualise the colour scheme found for the room decoration through on-site investigation and stratigraphy. (Source: the author)

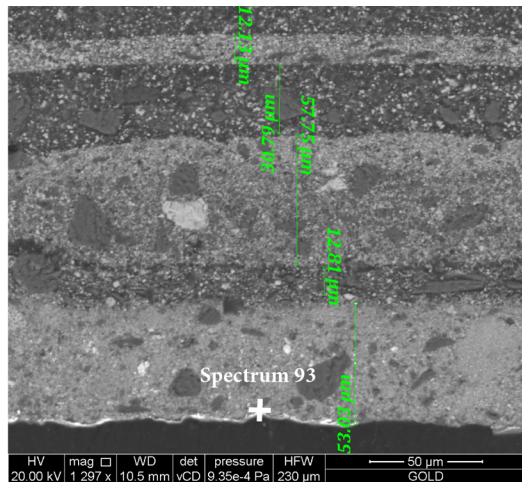
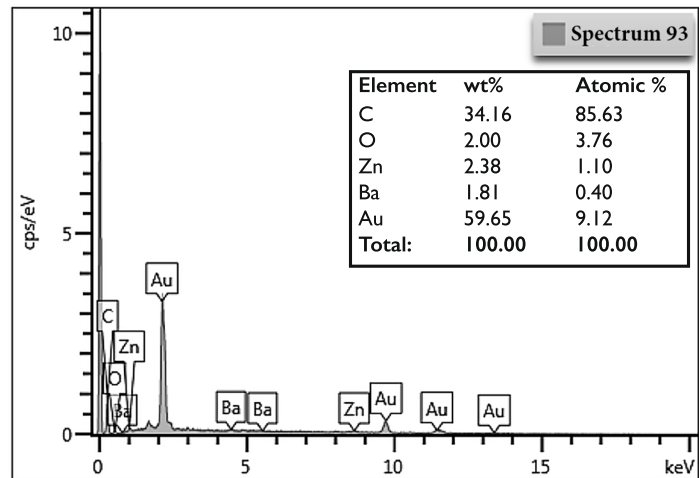
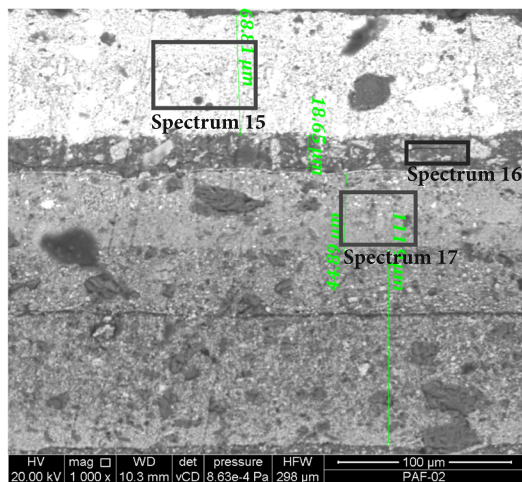
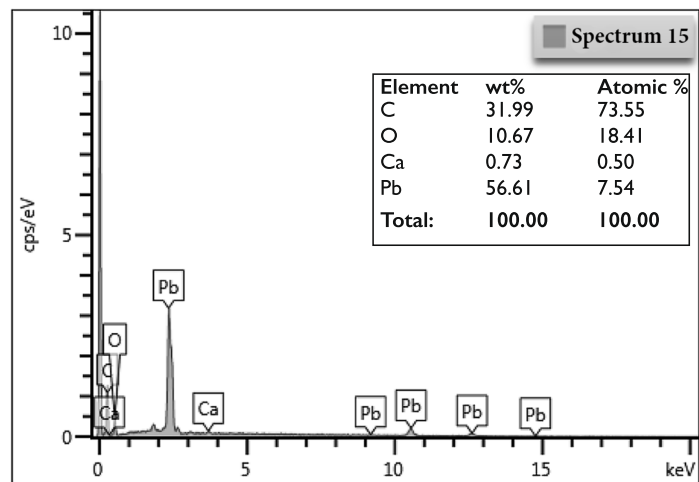
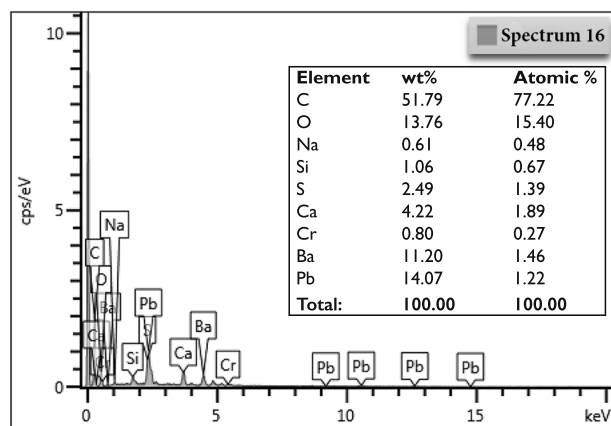
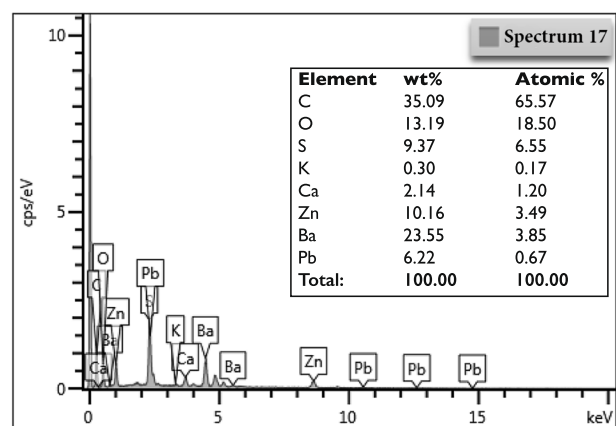
Within the frame of the preliminary investigation, initial SEM–EDS analysis was conducted on selected samples of paint finish around the coloured layers. Analysis was undertaken on single measurement points or small areas of approximately 0.05 mm². The gold observed on-site and in the sections was identified as real gold (Au) (Fig. 11a). In several of the white and cream layers lead (Pb) was detected. In the white layer immediately below the colour finish had the highest intensity of lead. All the layers, including the coloured ones, also showed the presence of zinc (Zn), barium (Ba), calcium (Ca), and sulfur (S) (Fig. 11b). FTIR analysis identified barium sulfate (Fig. 12). Titanium (Ti) was confirmed by EDS in one of the more recent finishes.

Fig. 11 **a** SEM micrograph of a section with gold leaf with corresponding EDS analysis showing gold. **b** SEM micrograph of a cross section with a red paint layer (red layers in the centre at spectrum 16 and 17) with corresponding EDS analysis showing lead in the white layer below the red layers. It should be noted that unlike common presentation of paint cross sections, both SEM images are inverted: the older layers appear uppermost, and so the gold ground appears above the gold leaf. Ba, S, Ca, and Zn in the red layers indicate filler materials. (Source: analysis of samples commissioned by Tongji Architectural Conservation Laboratory, analysed at the School of Chemistry of Xi'an Jiaotong University by Junyan Liang)

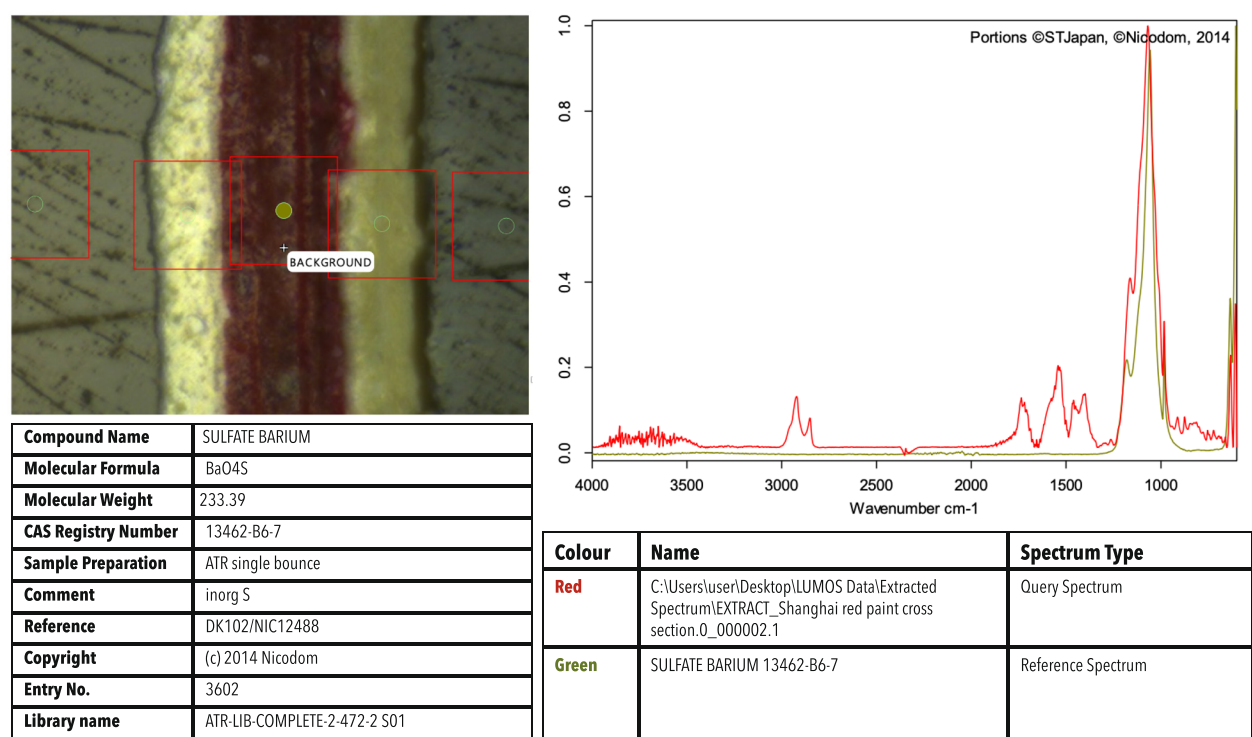
In synthetic form, white barium sulfate has been available since the early 19th century; it is chemically inert and used as an extender for lead white and as a base for the preparation of lake pigments. A mixture of barium sulfate and zinc sulfide, the compound lithopone is a common component in paints and colourants (Feller 1986). Most of the detected elements listed above appear to be related to filler materials in paint, such as lithopone and calcium carbonate. The results of the initial SEM and FTIR analysis indicated the use

Fig. 12 FTIR ATR point measurement of a red paint cross section and example reference showing that the paint contains barium sulfate (most likely included as a filler). (Source: preliminary FTIR analysis of samples collected by the author, analysis conducted at the Architectural Conservation Laboratory at The University of Hong Kong, Alison Trachet)

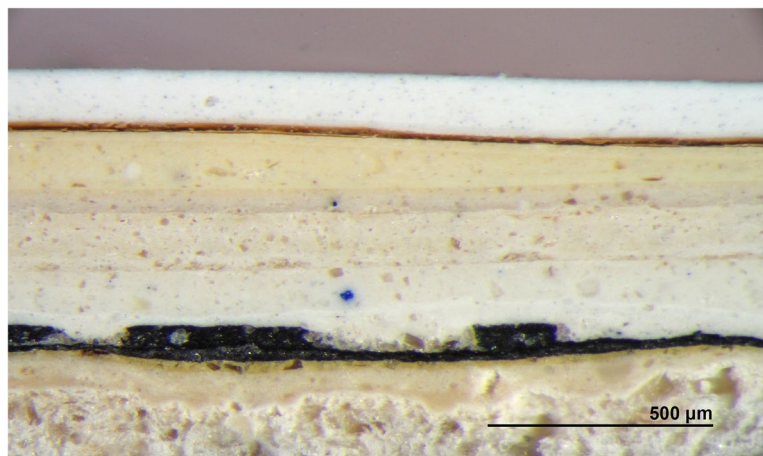
Fig. 13 Black paint layer. The cross section shows incomplete layers, indicating the previous scaling of the paint before applying white covering finishes. The beige or off-white primer is visible under the black finishes. (Source: the author)

In a cross section of the black paint, missing parts of the black finish could be observed (Fig. 13). The subsequent layer of white primer levelled out the uneven, damaged surface. This finding indicates that the paint finish—at least locally and in the black areas—showed signs

of deterioration and scaling before being covered. Lead was evident in the white base layer under the colour finishes and also in some of the white covering layers; this may signify the use of lead white pigment. Historically, this would be an obvious choice: finishes with lead white

pigment have particularly high hiding strength or hiding power²; this means that the paint finish would be able to fully cover over the strong colour decoration beneath. As a base layer, lead white pigment forms a bright white base for enhanced brilliance of the subsequent colour layers. However, in 1923 (when the building was completed: all paint finishes in this hall postdate 1923), many alternatives to poisonous lead paints were already on the market, such as zinc oxide and titanium white. It appears, however, that in early-20th-century China, there were no restrictions on using lead-containing pigments. In the author's previous experience when investigating and analysing paint finishes in public colonial buildings in Hong Kong (maintained by the government), lead-containing finishes were often evident. Identifying lead as a component in room decoration is important regarding plans for further interventions. Any paint removal would have to be conducted with proper care.
