Earthen architecture in the Iberian Peninsula: a portrait of vulnerability, sustainability and conservation

Camilla Mileto, Fernando Vegas López-Manzanares, Valentina Cristini*

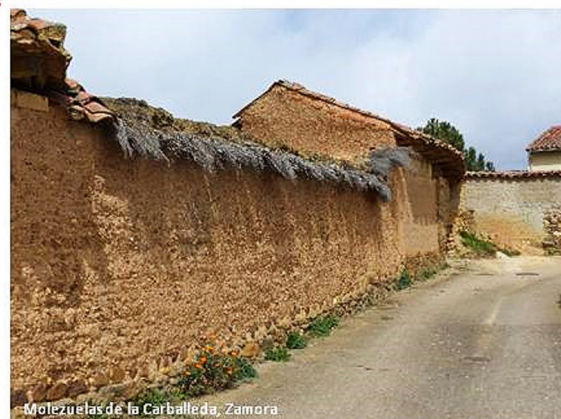
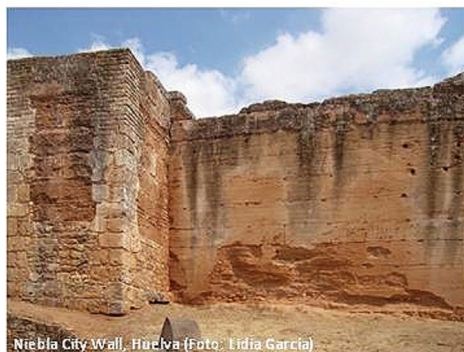
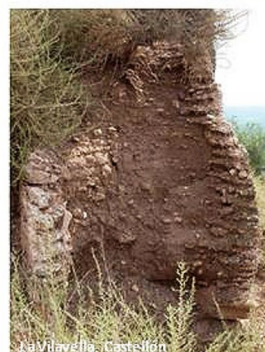
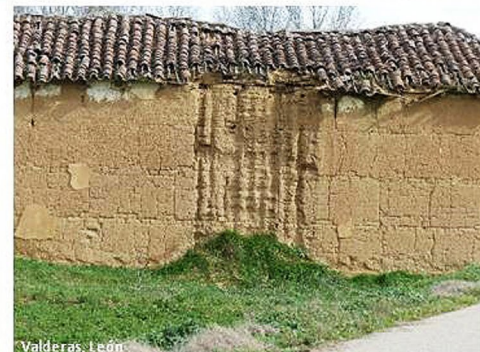
Phenomena and causes of the mechanisms of decay of earthen architecture

Fig. 4 Analysis of degradation phenomena by constructive technique, variant and wall section affected. Examples of degradations of the rammed earth group affected (Source: RES-TAPIA & SOS-TIERRA Projects)

Degradation phenomena were analysed depending on the section of wall they occur in (base, wall, crowning

and surface- Fig. 4) and the constructive variant of the wall analysed. The RES-TAPIA project marked the start of the analysis of degradation phenomena in this type of wall, while the SOS-TIERRA Project continued with the analysis of degradation phenomena in the other earthen constructive techniques.

usually leading to a series of associated degradation problems (Fig. 4).

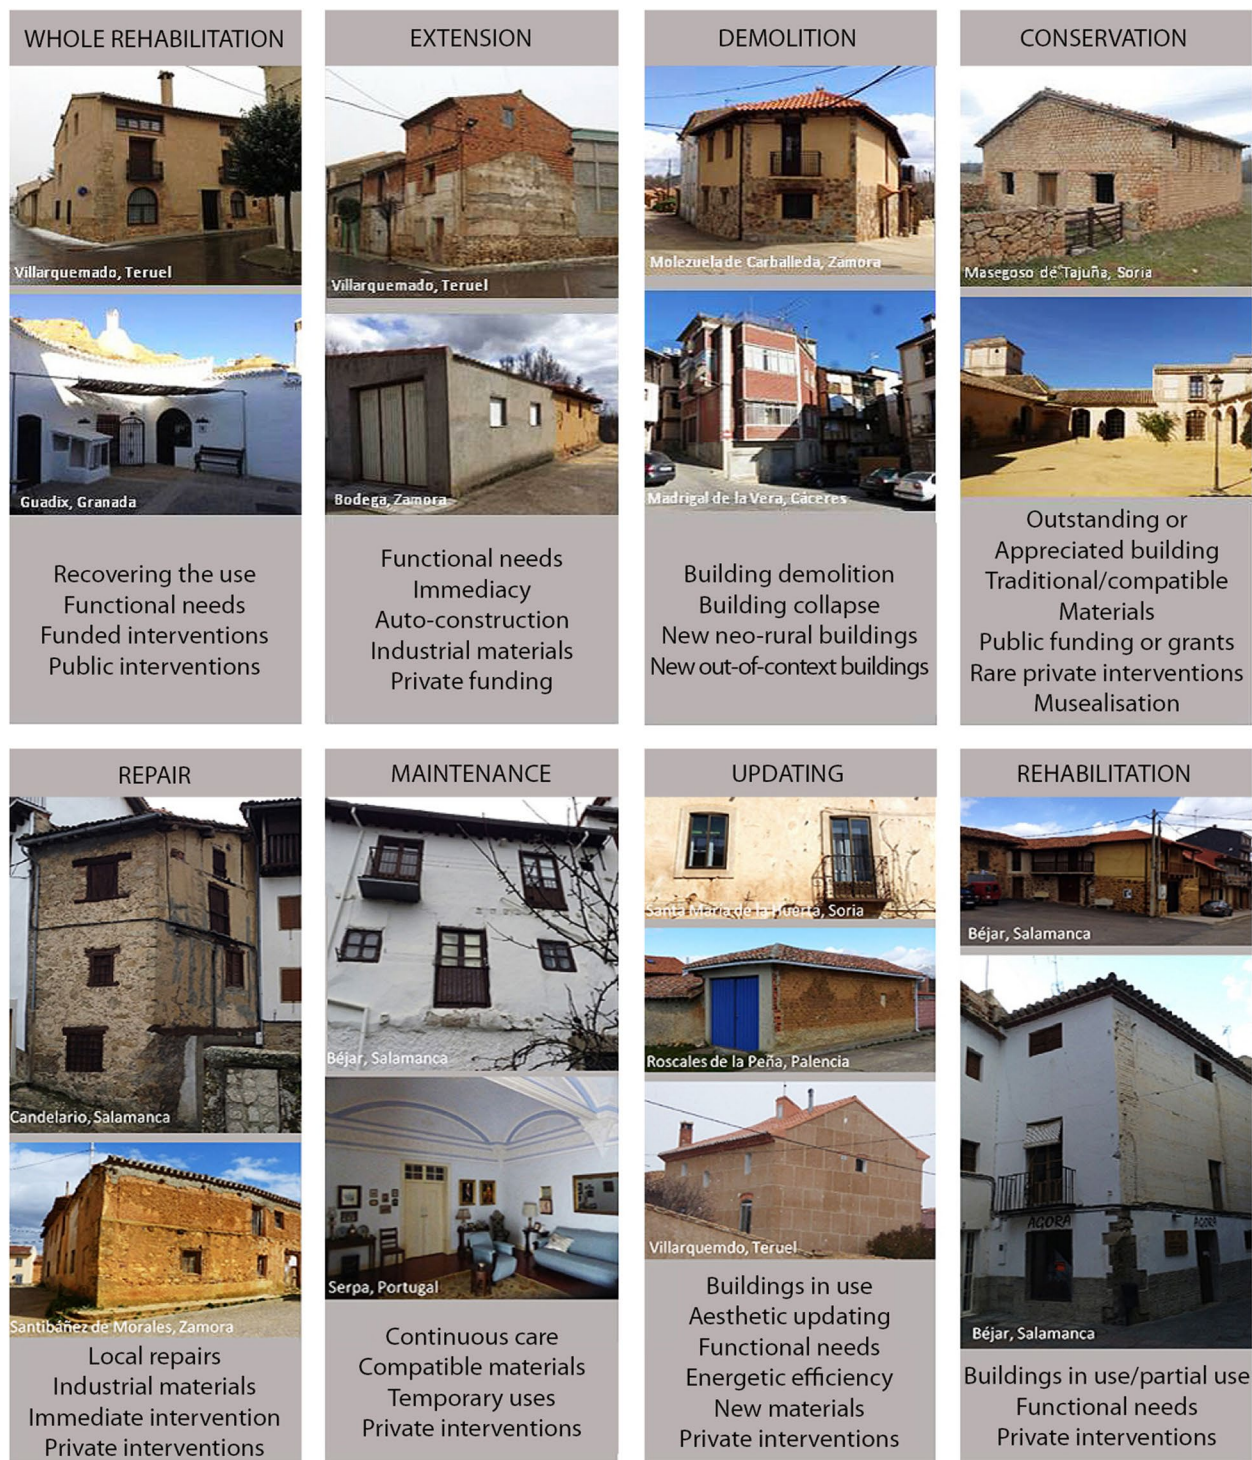
Fig. 5 Examples of interventions and criteria concerning historic earthen architecture. Related to the main 8 actions stressed in the projects (whole rehabilitation, extension, demolition, conservation, repair, maintenance, updating, partial rehabilitation (Source: RES-TAPIA & SOS-TIERRA Projects)

Based on these projects a series of eight codified interventions were proposed as technical solutions which constitute examples of possible specific solutions (Fig. 5). These proposals have focused on earthen walls
